Prepared for:
National Grid
Brooklyn, NY

Prepared by:
AECOM
Manhattan, NY
60137362
August, 2015

Annual Report Interim Remedial Measure for NAPL Recovery

**Former Equity Works MGP Site
Brooklyn, New York
NYSDEC Site No.: 224050
Order on Consent Index #: A2-0552-0606**

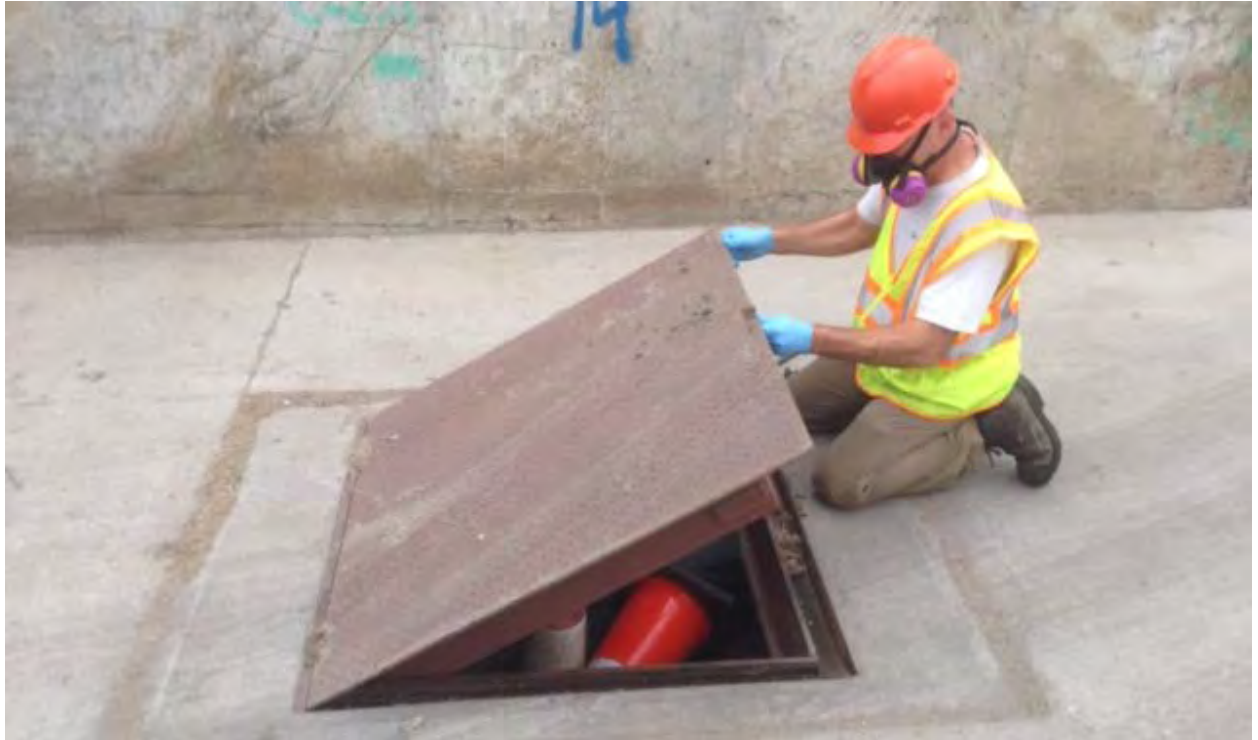
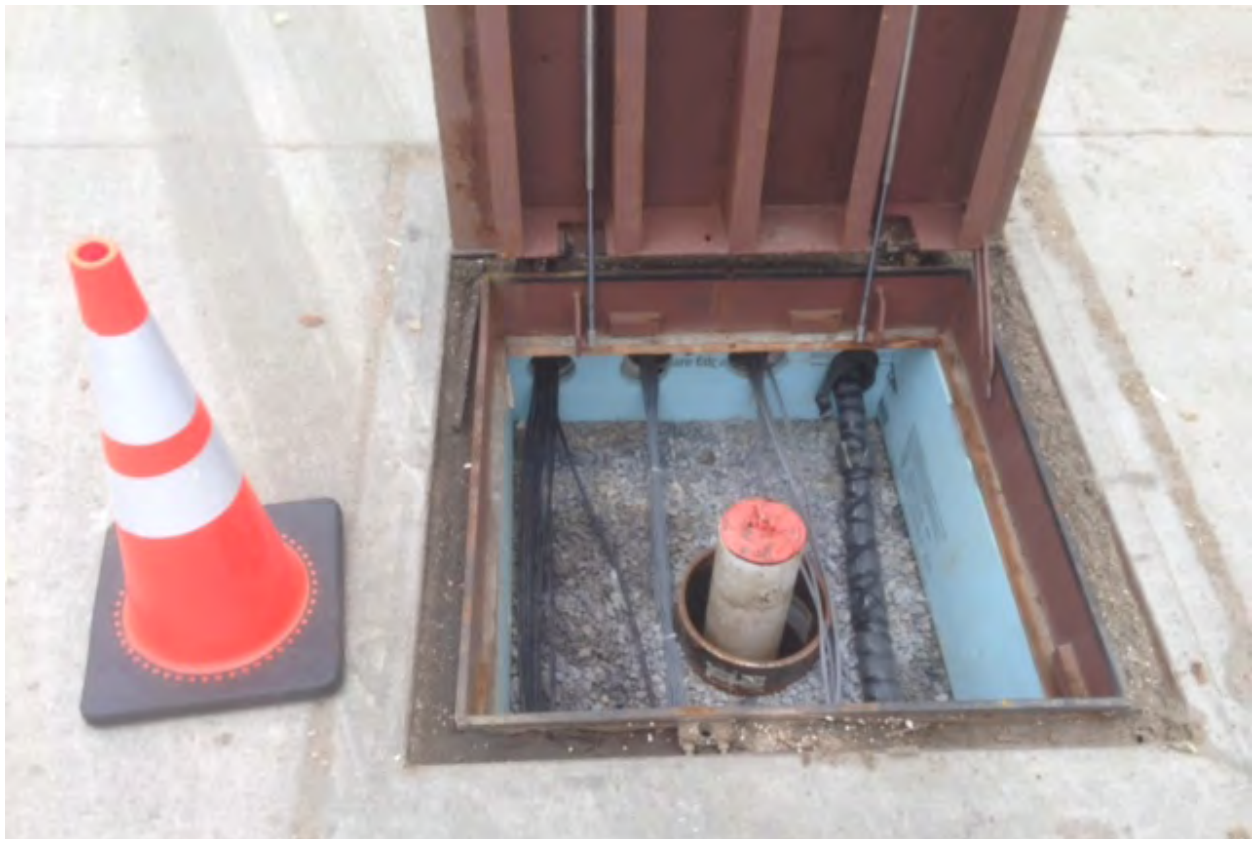
Figure 2-2

Recovery wells were designed to accommodate the uncertainty of long-term NAPL recovery rates. All well risers were constructed of 6-inch diameter schedule 40 polyvinyl chloride (PVC). Recovery well screens were constructed of 6-inch diameter 0.020-inch slot wire wrap stainless steel. Five (5) and ten (10 foot lengths of screen were used, as required, to address soil intervals where NAPL (i.e., saturated thickness greater than 1-inch) have been observed. Centralizers were installed at the top and bottom of each screen. The screen size was selected based on the grain-size information obtained during the Pre-Design Investigation (PDI). Each well was equipped with a 5-foot long, 6-inch diameter, stainless steel sump to collect NAPL. The annular space above the filter pack was filled with a bentonite seal (minimum of 3 to 4 feet thick). Note that additional bentonite seals were used at locations where multiple screen intervals were installed. The annular space above the bentonite seal was filled with a grout mixture from the bentonite seal to approximately one to two feet below the top of casing (TOC). Each recovery well was completed in a 4-foot by 4-foot traffic rated well vault. Illustrations of an in-place recovery well and completed well location are provided in Figure 2-2.

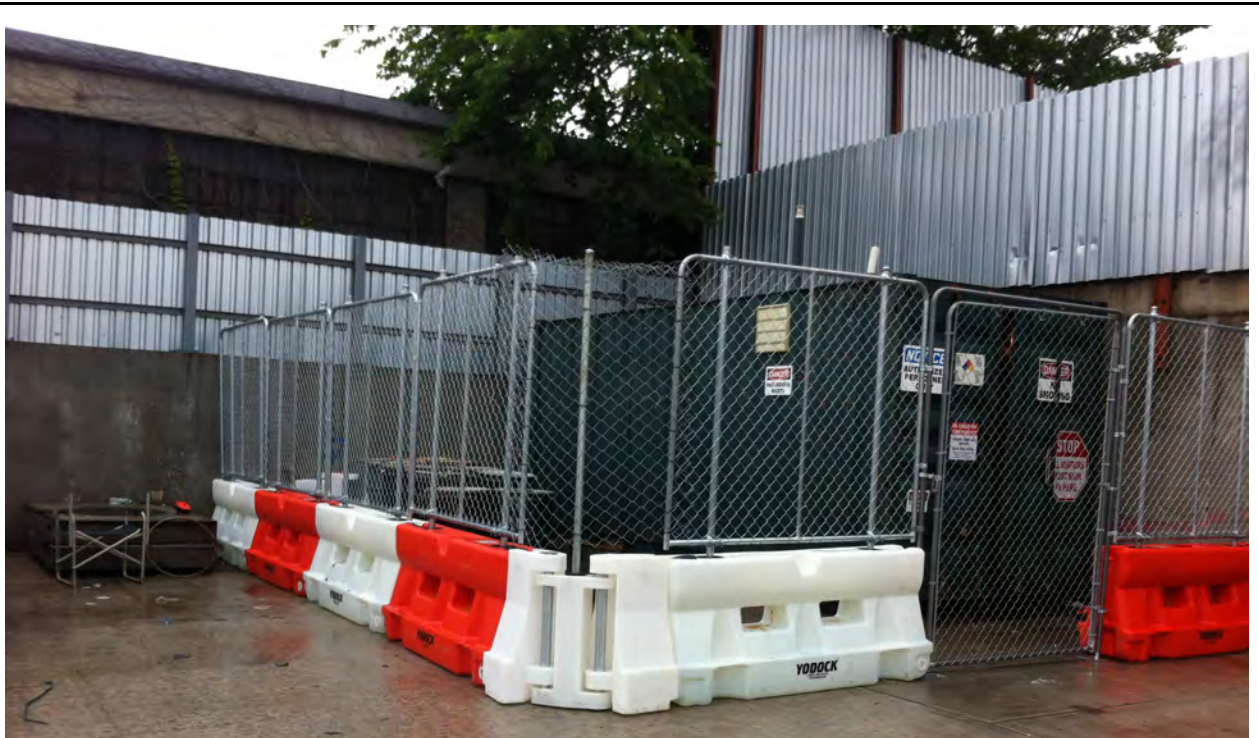
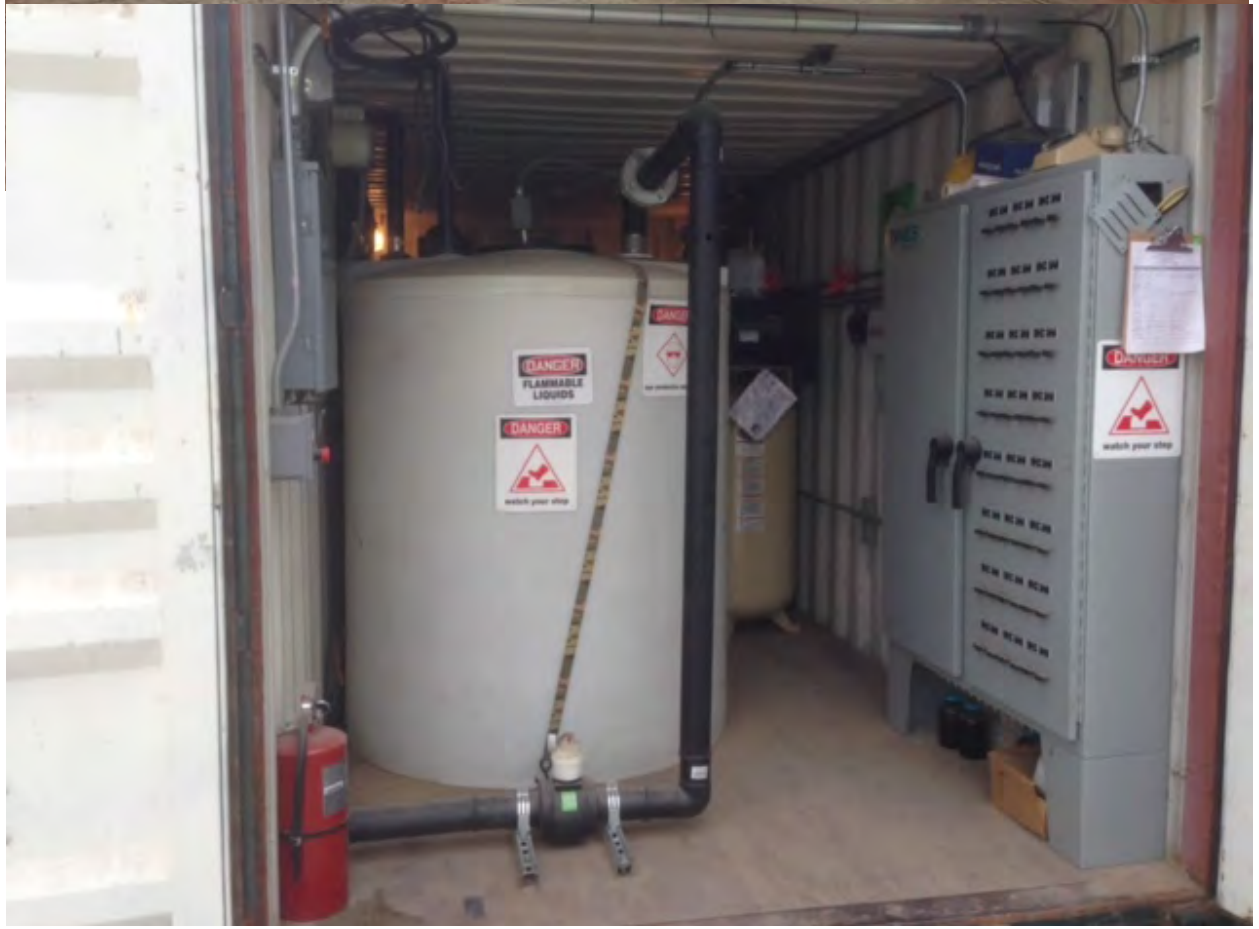
Figure 2-4

Collected NAPL is accumulated in a 500 gallon capacity double-walled polyethylene tank located above ground in the system's control trailer on the 254 parcel (Figure 2-4). The accumulation tank is equipped with a high liquid level detector to prevent over-filling, as well as secondary containment. The system is equipped with additional alarms and communication equipment to ensure its safe operation.

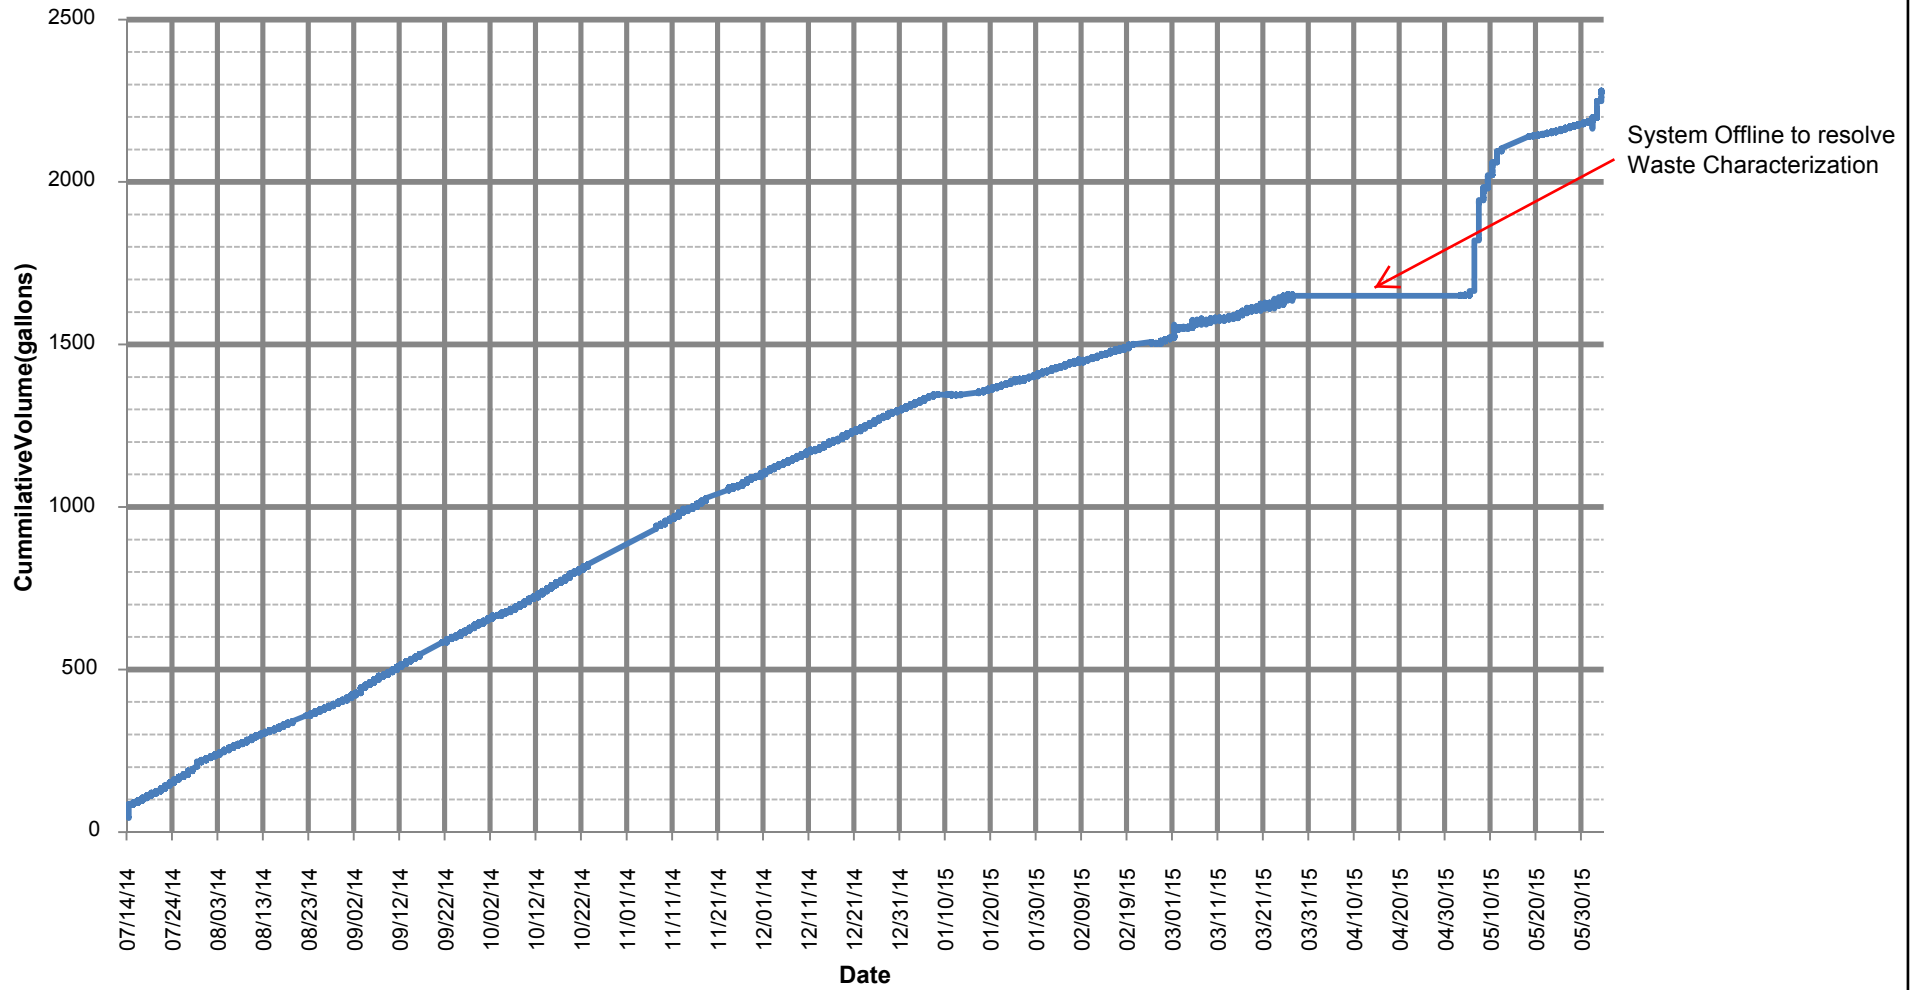
Figure 3-1

Note: Mixed Fluids are estimated to contain 80% NAPL

adjustments of the pumping rates. The results from a monitoring event conducted on June 3, 2015 demonstrated that pumping rates are appropriate to contain NAPL levels within the sumps. Approximately 2,270 gallons of mixed fluids have been collected from the system during the initial operating period. An illustration of the cumulative volume of mixed fluids collected over time is provided in Figure 3-1. Observations of the collected material indicate an approximate 80:20 ratio of organic to water, providing for a NAPL collection rate of approximately 6 gallons per day.
