Re: Supplemental Investigation Report – 222 Maspeth Avenue Property  
Former Equity Works Manufactured Gas Plant (MGP) Site  
Brooklyn, New York  
NYSDEC Site No. 224050, Order on Consent Index #: A2-0552-0606

# Supplemental Investigation Report – 222 Maspeth Avenue

Former Equity Works MGP Site  
222-254 Maspeth Avenue Brooklyn, Kings County, New York  
NYSDEC Site No.: 224050  
Order of Consent Index #: A2-0552-0606

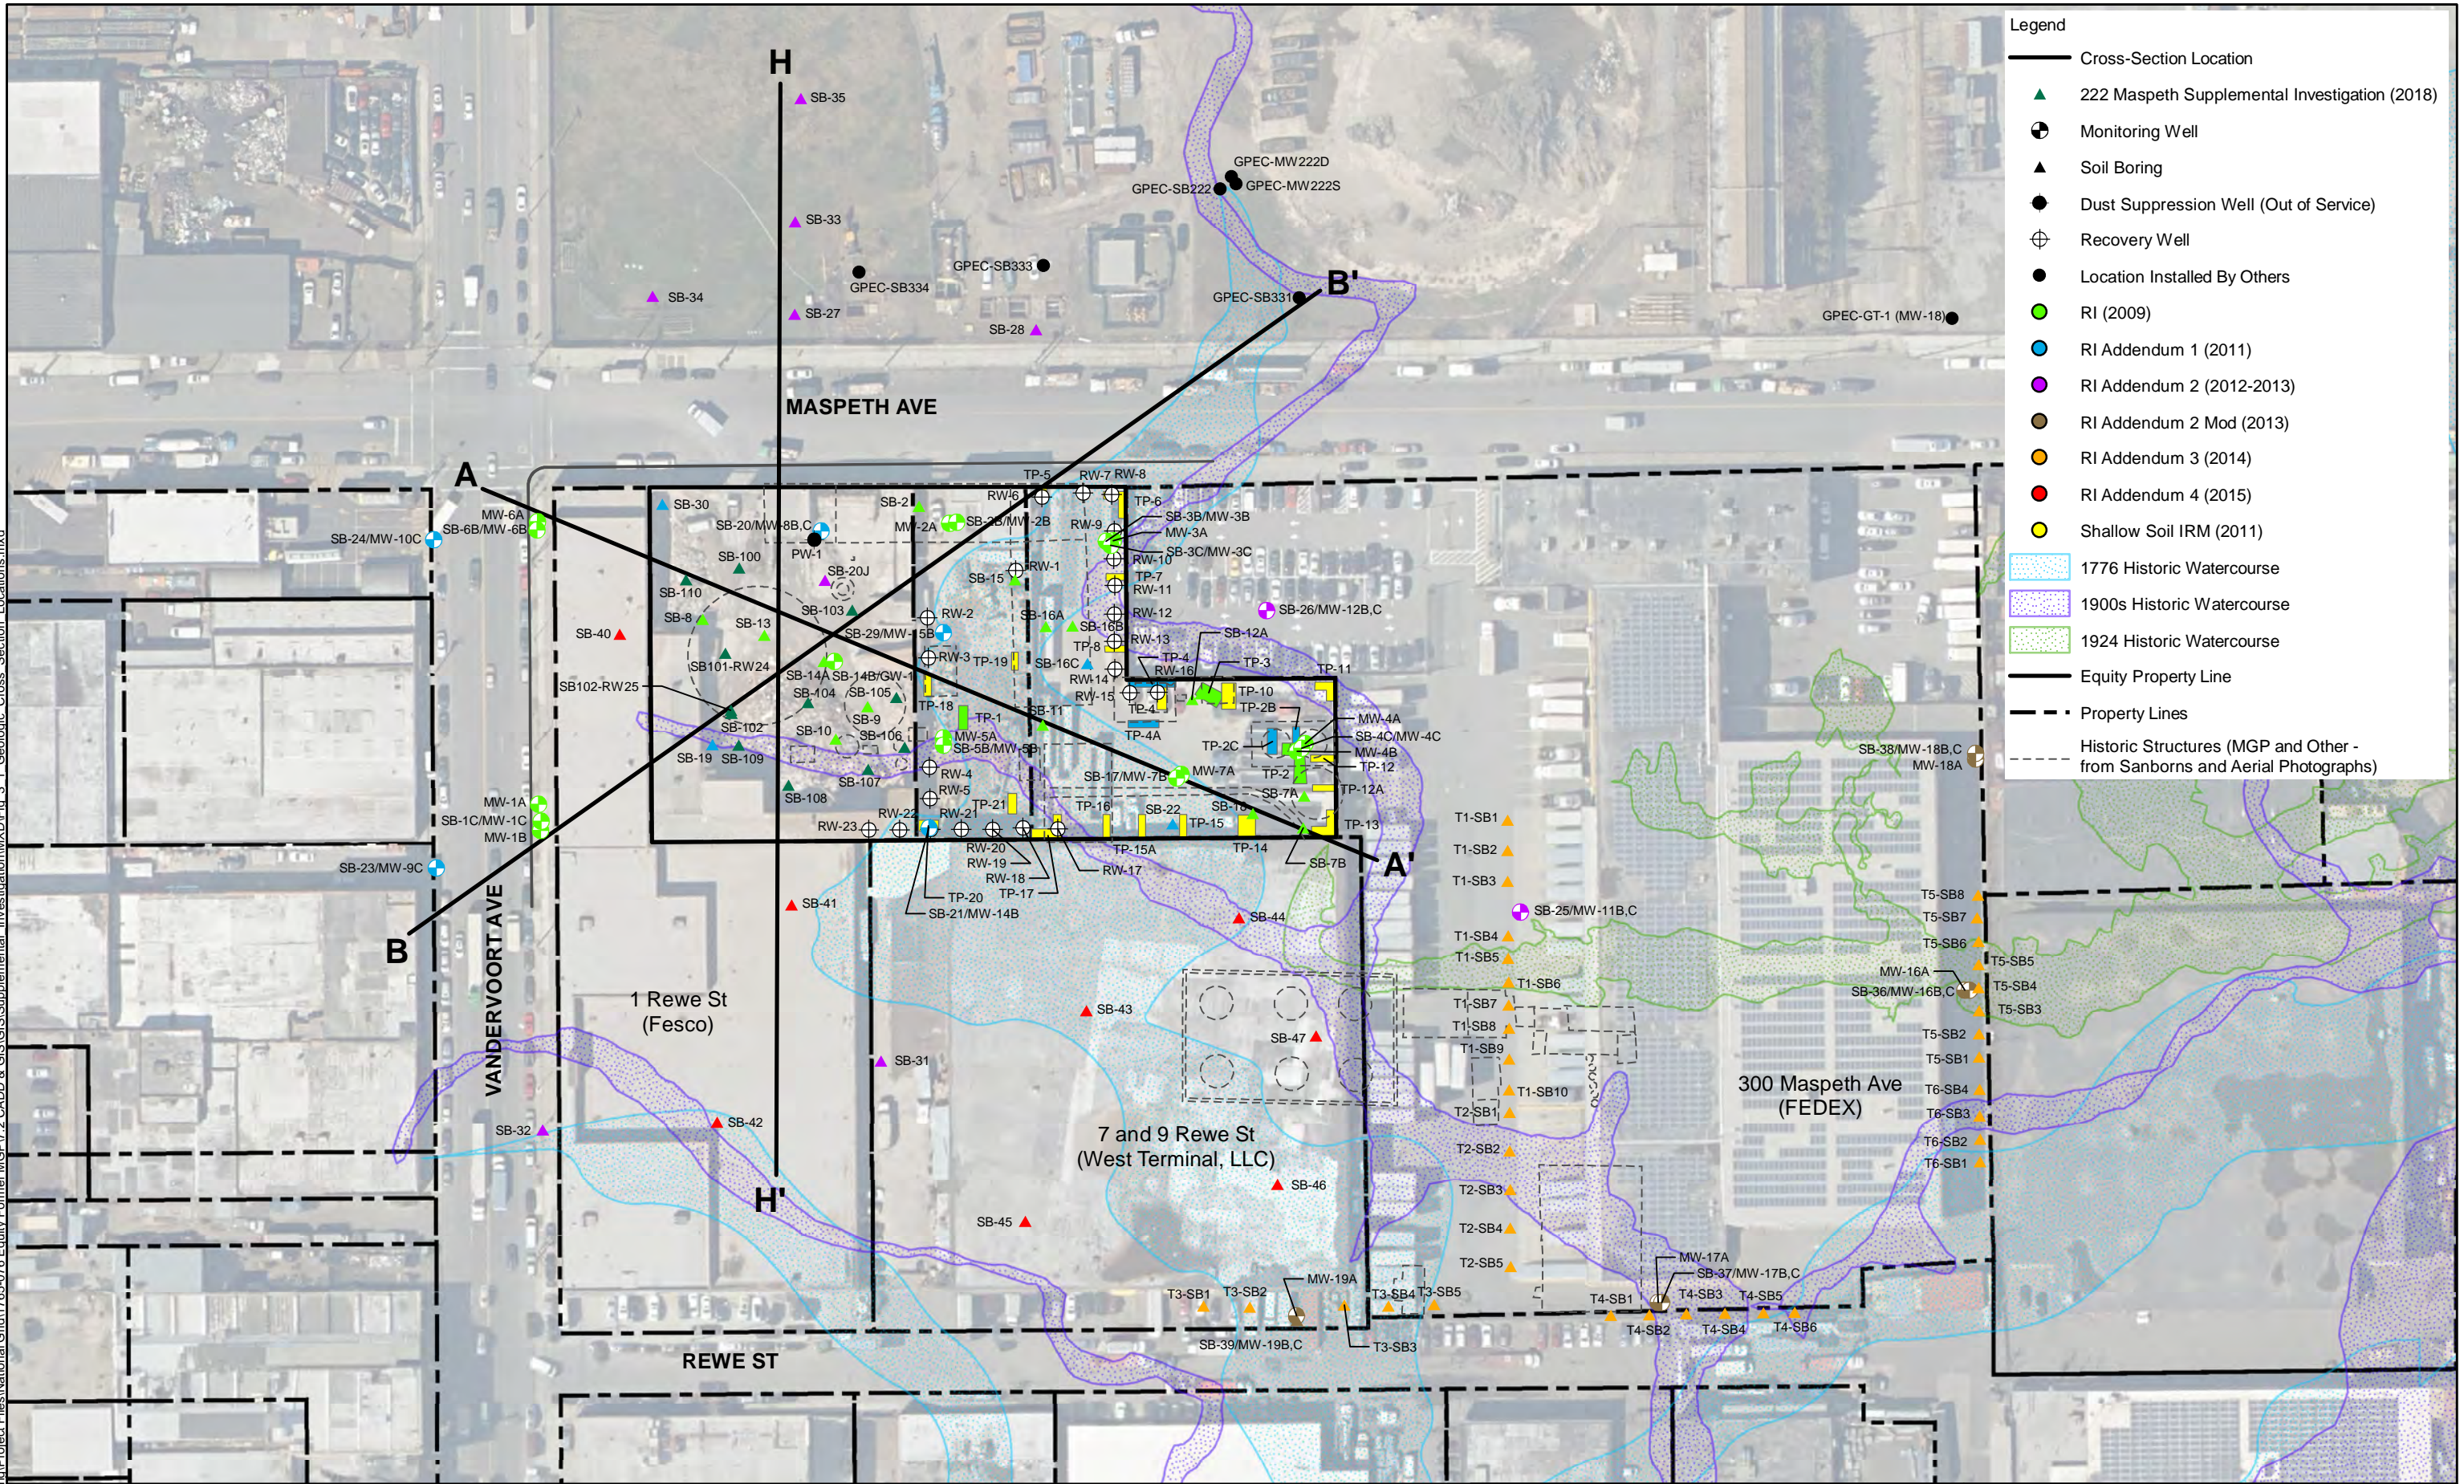
FIGURE 3-1  
GEOLOGIC CROSS-SECTION LOCATIONS

- Within the intermediate sand unit underlying the meadow mat and overlying the lower conductivity intermediate clay unit, with the exception of the borings SB-109 and SB-110 which are west of where the intermediate clay unit was not observed (Figure 2-2, Figure 3-1, and Figure 3-6). Visible impacts within the intermediate sand unit and above the intermediate clay unit are also illustrated on the geologic cross sections, including A-A' (Figure 3-2), B-B' (Figure 3-3), and H-H' (Figure 3-4) and the geologic boring logs (Appendix A).

- Within the lower sand unit underlying the intermediate clay and overlying the lower conductivity lower clay and or Gardiners Clay at one of the three deep borings advanced to these depth intervals (SB-109 (Figure 2-2, Figure 3-1, and Figure 3-7). At borings SB-104 and SB-110, no visible impacts were noted at these depth intervals. Visible impacts within the lower sands and above the lower clay and/or Gardiners Clay unit are also illustrated on the geologic cross sections, including A-A' (Figure 3-2), B-B' (Figure 3-3), and H-H' (Figure 3-4) and the geologic boring logs (Appendix A). Please note that cross sections G through G from the 2016 RI (AECOM, 2016) were not updated as part of the SI work.

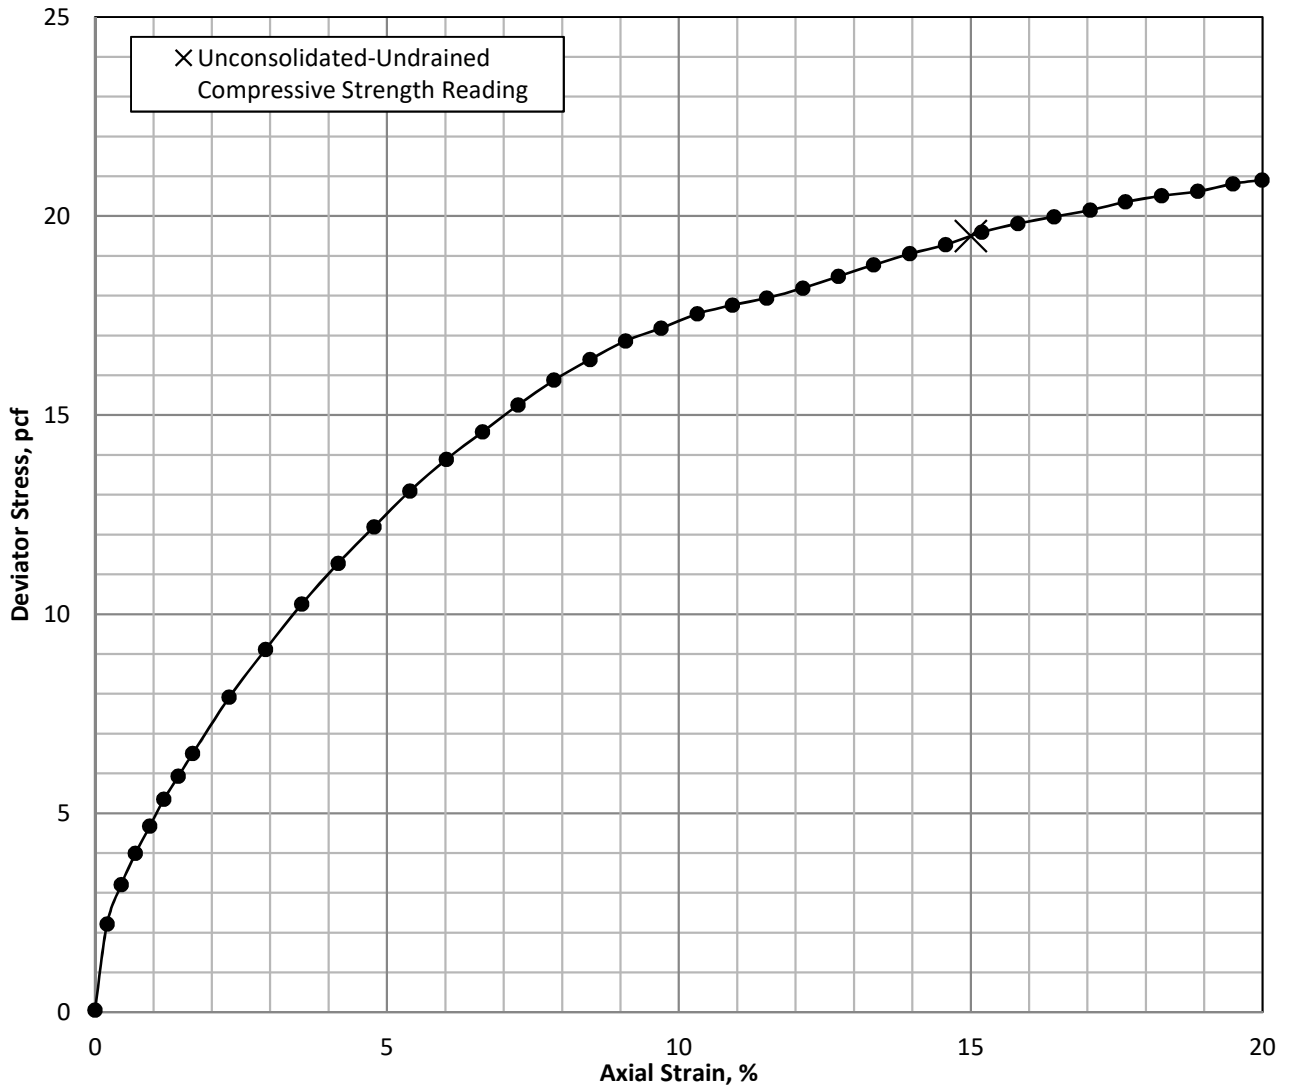
**UNCONSOLIDATED-UNDRAINED COMPRESSIVE STRENGTH TEST, ASTM METHOD D2850**

Specimen and Material Property Information											
Sample Type: Intact tube sample											
Description and/or Classification: CL, brown clay											
Cell Pressure (pcf)	Water Content (%) <sup>(1)</sup>	Wet Unit Weight (pcf)	Dry Unit Weight (pcf) <sup>(1)</sup>	Void Ratio (-)	Saturation (%) <sup>(2)</sup>	Length (inch)	Diameter (inch)	L/D (-)	LL/PL (-)	PI (-)	Specific Gravity (-) <sup>(2)</sup>
0 (Initial)	28.4	124.5	96.9	0.81	99.1	5.980	2.860	2.1	37	17	2.81
16.0	28.4	124.9	97.3	0.80	99.9	5.973	2.857	2.1	20

Failure Summary			
U-U Compressive Strength (pcf)	U-U Shear Strength, $s_u$ (pcf)	Strain to Peak (%)	Strain Rate (%/min)
19.5	9.75	15.0	0.74

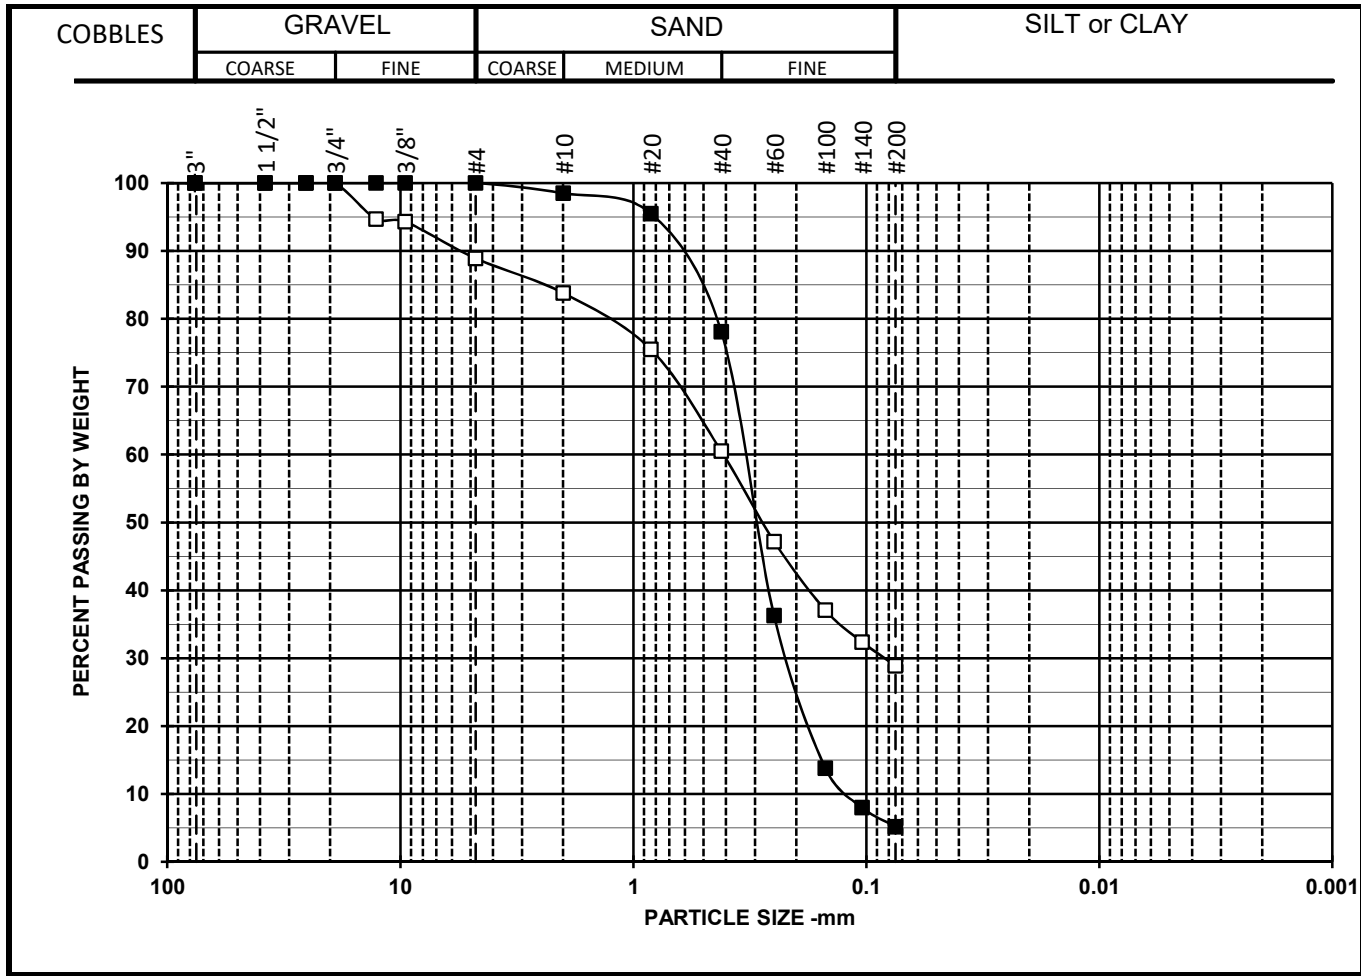
Symbol	□	■	○
Boring	SB-103	SB-106	
Sample			
Depth	11-13	33-35	
% +3"	0.0	0.0	
% Gravel	11.1	0.0	
% SAND	60.0	94.8	
%C SAND	5.1	1.5	
%M SAND	23.3	20.4	
%F SAND	31.6	72.9	
% FINES	28.9	5.2	
D <sub>100</sub> (mm)	19.050	4.750	
D <sub>60</sub> (mm)	0.411	0.334	
D <sub>30</sub> (mm)	0.083	0.216	
D <sub>10</sub> (mm)		0.118	
Cc		1.200	
Cu		2.8

Sieve	Percent Finer Data	
Size/ID #	SB-103 (%)	SB-106 (%)
6"	100.0	100.0
4"	100.0	100.0
3"	100.0	100.0
1 1/2"	100.0	100.0
1"	100.0	100.0
3/4"	100.0	100.0
1/2"	94.7	100.0
3/8"	94.3	100.0
#4	88.9	100.0
#10	83.8	98.5
#20	75.5	95.5
#40	60.5	78.1
#60	47.2	36.3
#100	37.1	13.8
#140	32.4	8.0
#200	28.9	5.2
5 μm	9.2	0.3
2 μm		
1 μm

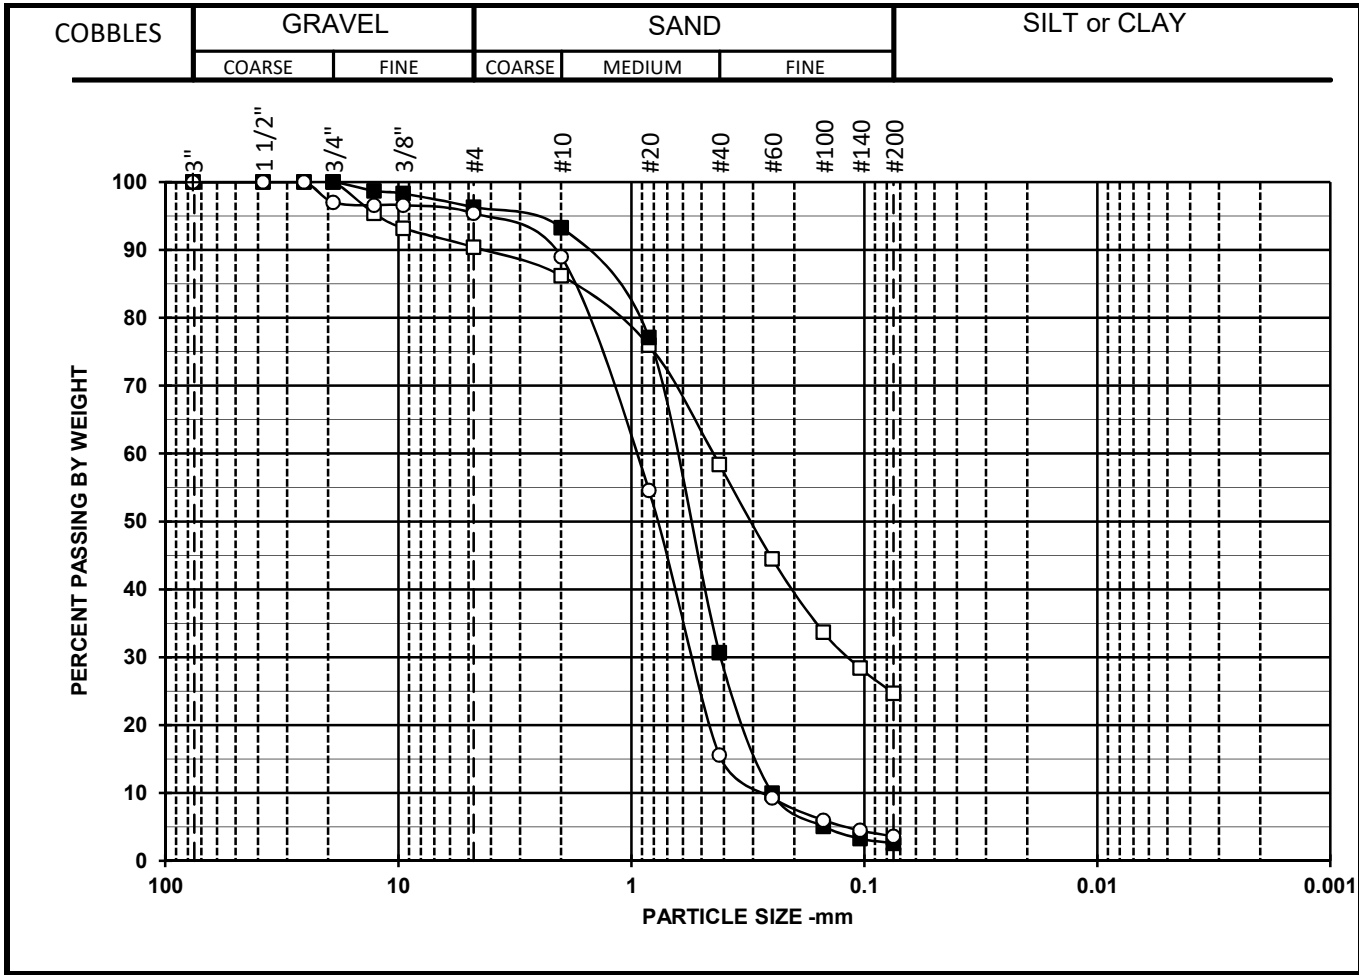
Symbol	□	■	○
Boring	SB-109	SB-109	SB-110
Sample			
Depth	11-13	59-61	67-69
% +3"	0.0	0.0	0.0
% Gravel	9.6	3.7	4.6
% SAND	65.7	93.7	91.8
%C SAND	4.2	3.0	6.4
%M SAND	27.8	62.6	73.4
%F SAND	33.7	28.1	12.0
% FINES	24.7	2.6	3.6
D <sub>100</sub> (mm)	19.050	19.050	25.400
D <sub>60</sub> (mm)	0.446	0.650	0.963
D <sub>30</sub> (mm)	0.116	0.412	0.542
D <sub>10</sub> (mm)		0.249	0.264
Cc		1.000	1.200
Cu		2.6	3.7

Sieve	Percent Finer Data		
Size/ID #	□	■	○
6"	100.0	100.0	100.0
4"	100.0	100.0	100.0
3"	100.0	100.0	100.0
1 1/2"	100.0	100.0	100.0
1"	100.0	100.0	100.0
3/4"	100.0	100.0	97.0
1/2"	95.4	98.7	96.6
3/8"	93.2	98.3	96.6
#4	90.4	96.3	95.4
#10	86.2	93.3	89.0
#20	76.0	77.1	54.6
#40	58.4	30.7	15.6
#60	44.5	10.0	9.3
#100	33.7	5.1	6.0
#140	28.4	3.3	4.5
#200	24.7	2.6	3.6
5μ m			
2μ m			
1μ m

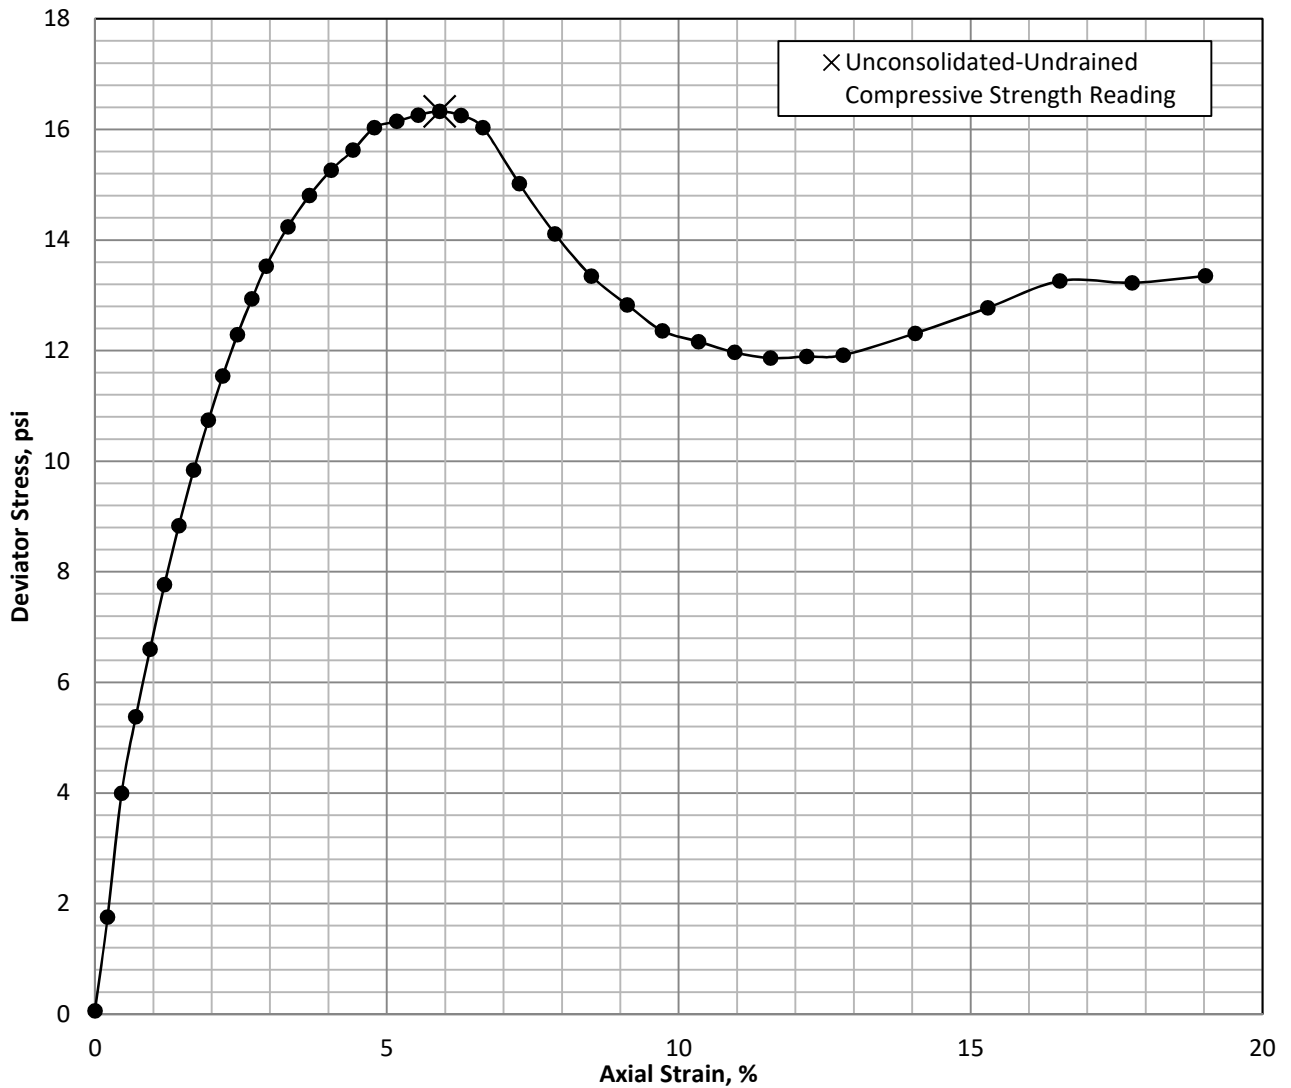
**UNCONSOLIDATED-UNDRAINED COMPRESSIVE STRENGTH TEST, ASTM METHOD D2850**

Specimen and Material Property Information											
Sample Type: Intact tube sample											
Description and/or Classification: CH, brown fat clay											
Cell Pressure (psi)	Water Content (%) <sup>(1)</sup>	Wet Unit Weight (pcf)	Dry Unit Weight (pcf) <sup>(1)</sup>	Void Ratio (-)	Saturation (%) <sup>(2)</sup>	Length (inch)	Diameter (inch)	L/D (-)	LL/PL (-)	PI (-)	Specific Gravity (-) <sup>(2)</sup>
0 (Initial)	40.8	114.3	81.1	1.15	99.1	5.984	2.866	2.1	53	31	2.80
19.0	40.8	114.9	81.5	1.14	100.0	5.974	2.861	2.1	22

Failure Summary			
U-U Compressive Strength (psi)	U-U Shear Strength, $s_u$ (psi)	Strain to Peak (%)	Strain Rate (%/min)
16.3	8.15	5.9	0.74

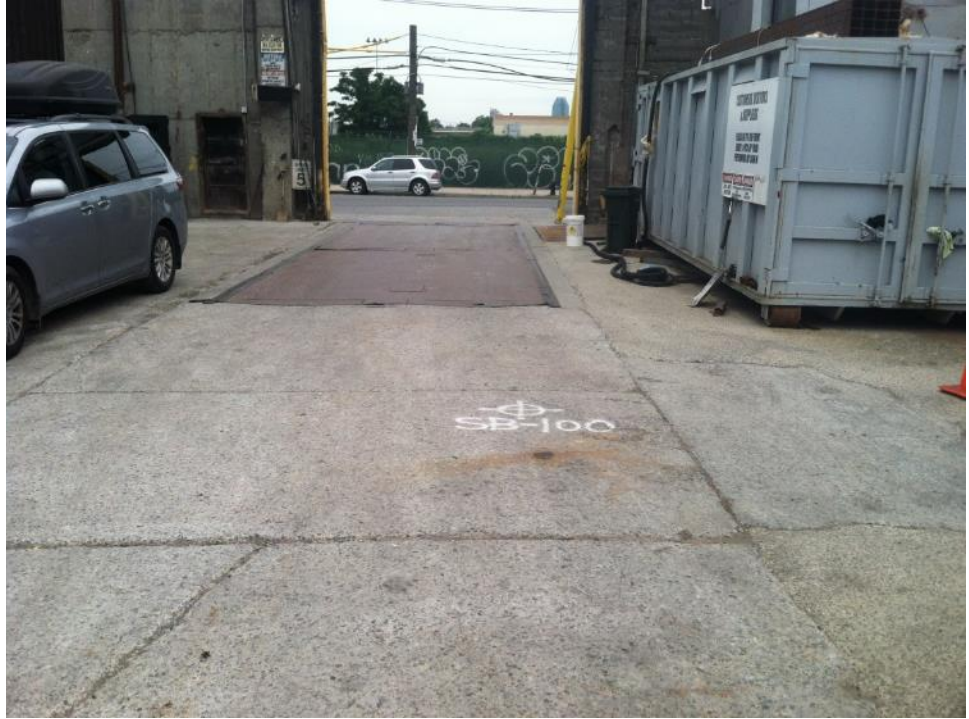
View of the entrance to 222 Maspeth Avenue as well general conditions on the northwestern portion of the lot in vicinity of SB-100 location.

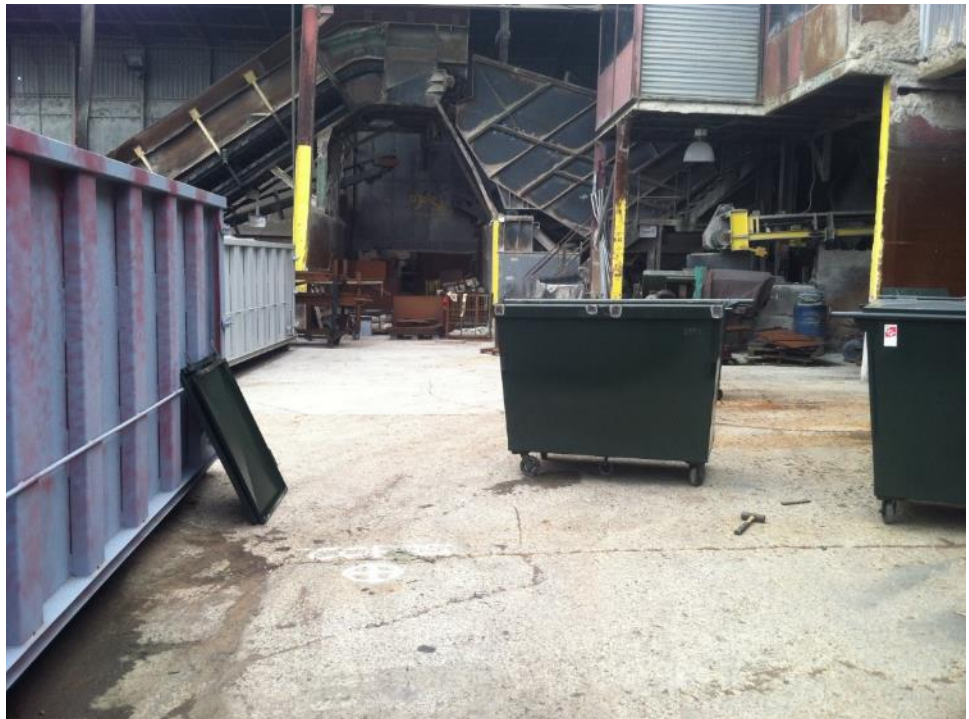
**Photo No.**  
2

General conditions on the southwestern portion of 222 Maspeth in vicinity of SB-102 and SB-109 locations.

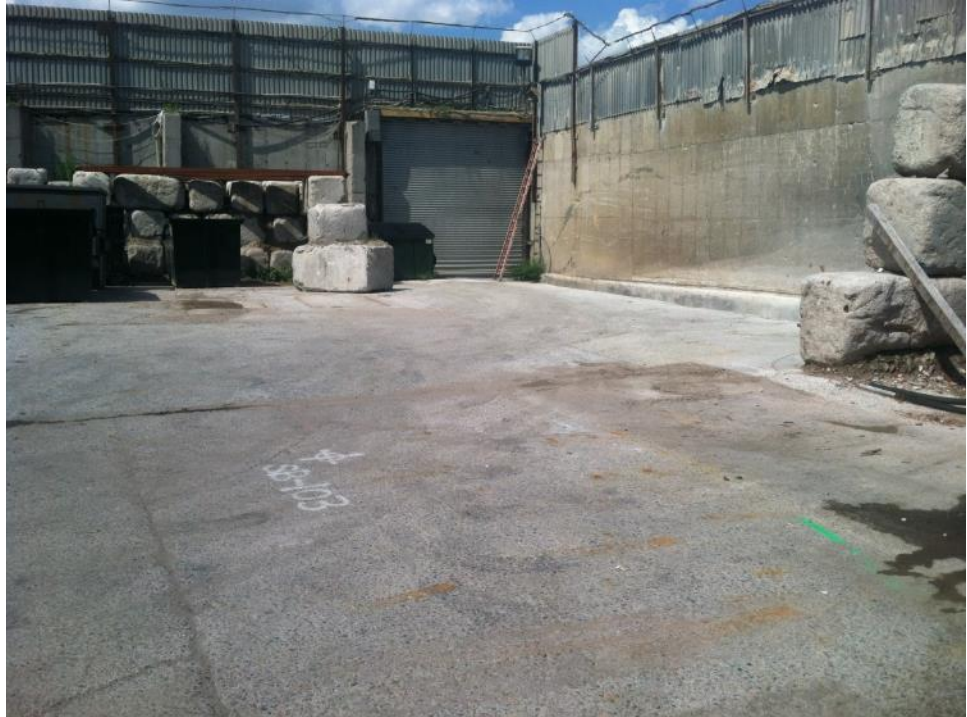
General conditions on the northeastern portion of 222 Maspeth in vicinity of SB-103 location.

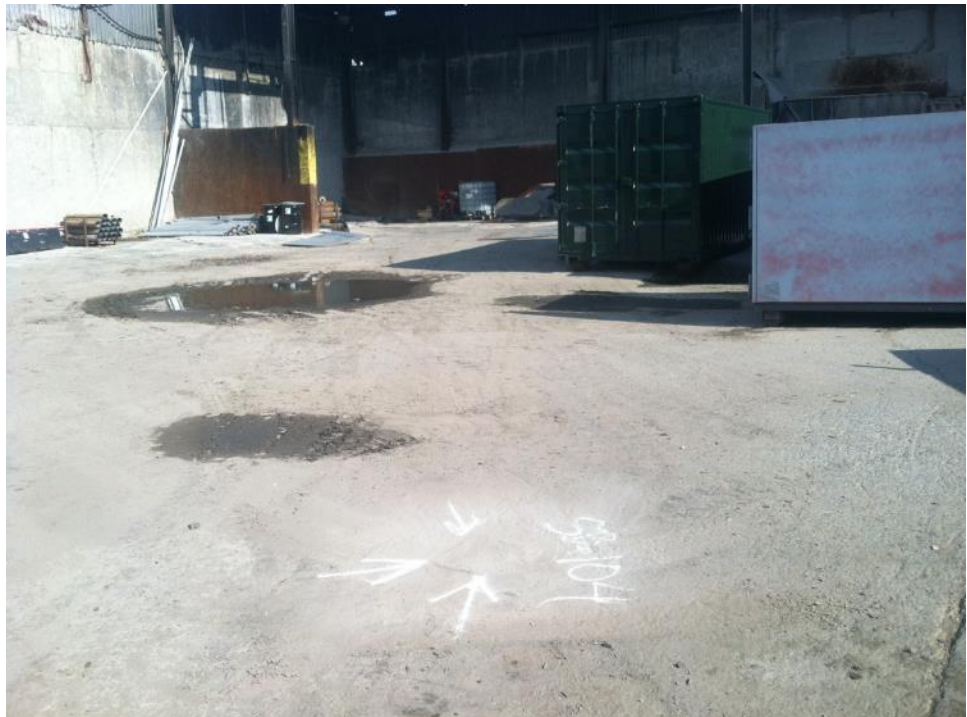
**Photo No.**  
4

General conditions on the central and southeastern portions of 222 Maspeth in vicinity of SB-104 and SB-107 locations.

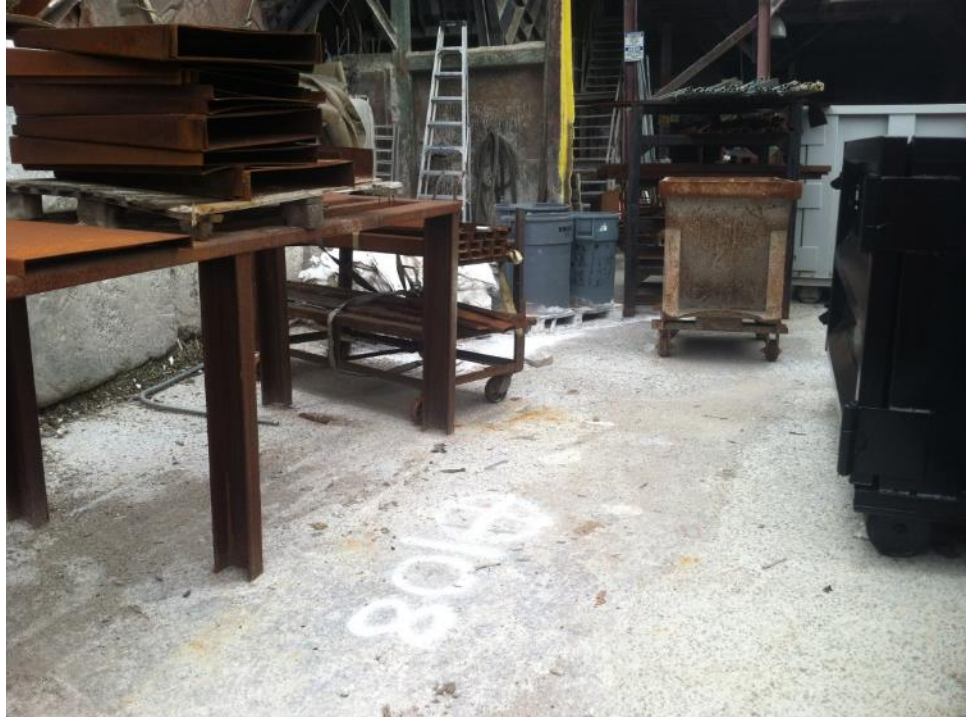
General conditions on the southern portion of 222 Maspeth in vicinity of SB-108 location.

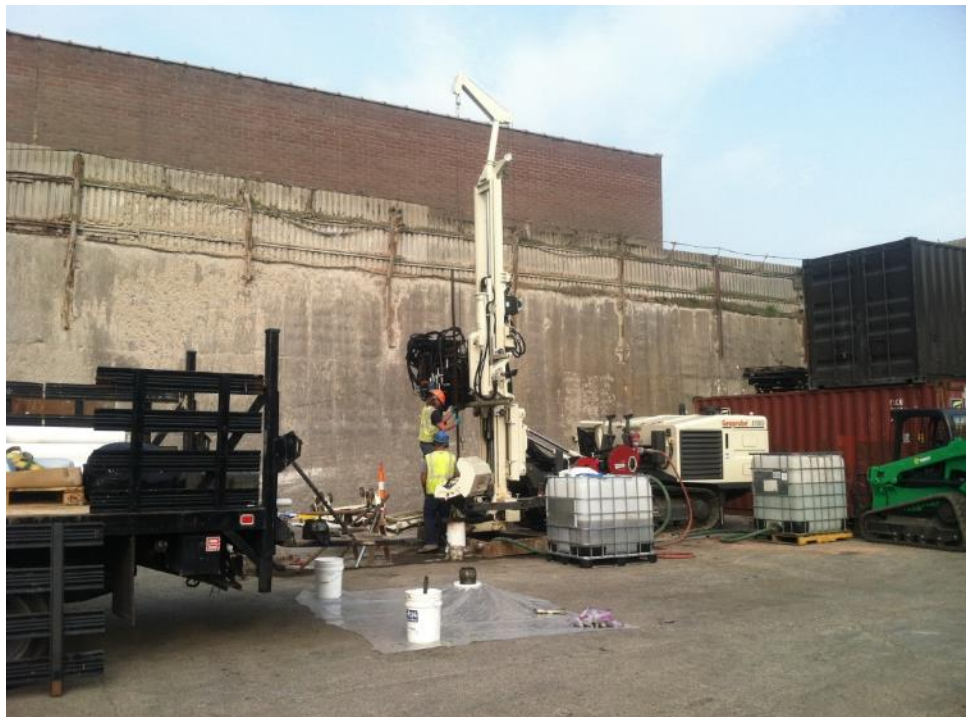
Drill rig setup on the northwestern portion of 222 Maspeth (SB-110 location).

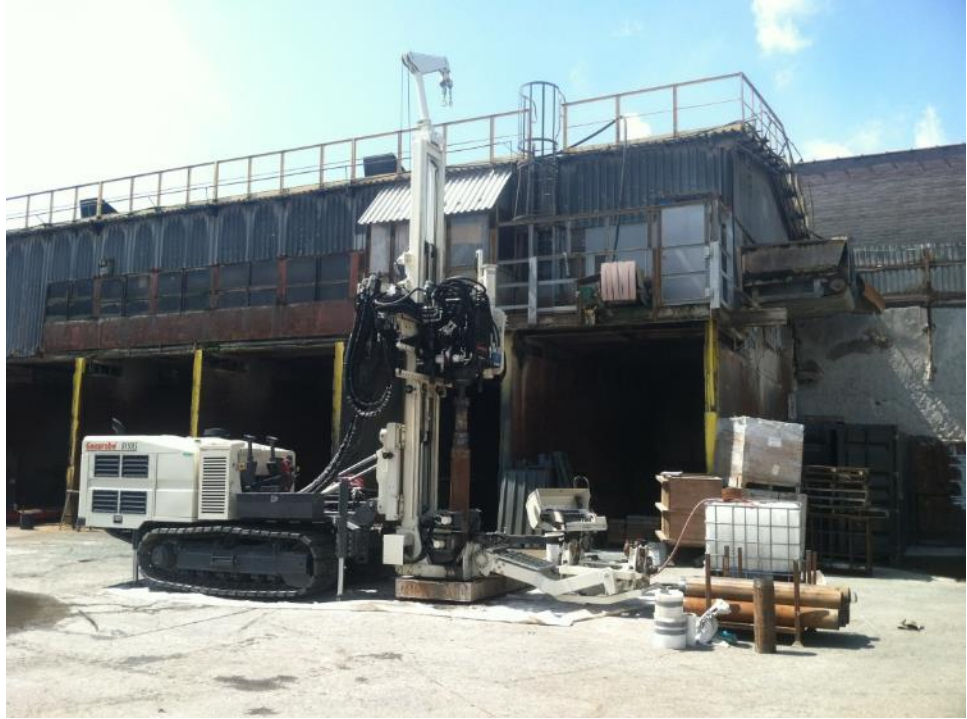
Drill rig setup on the western portion of 222 Maspeth (SB-101 location).

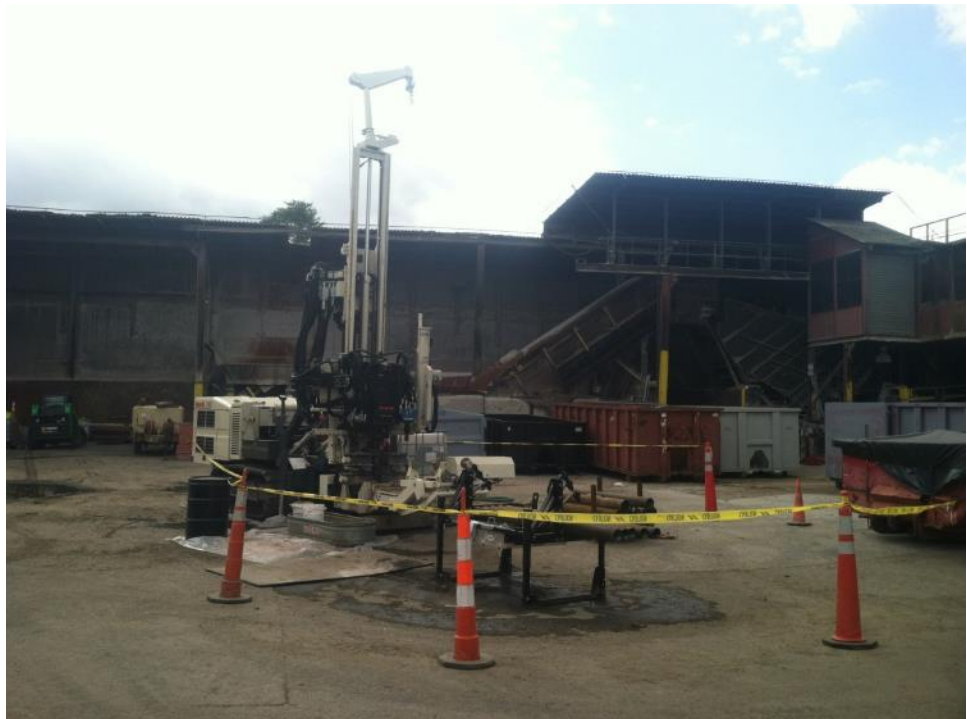
8

Drill rig setup on the central portion of 222 Maspeth (SB-104 location).

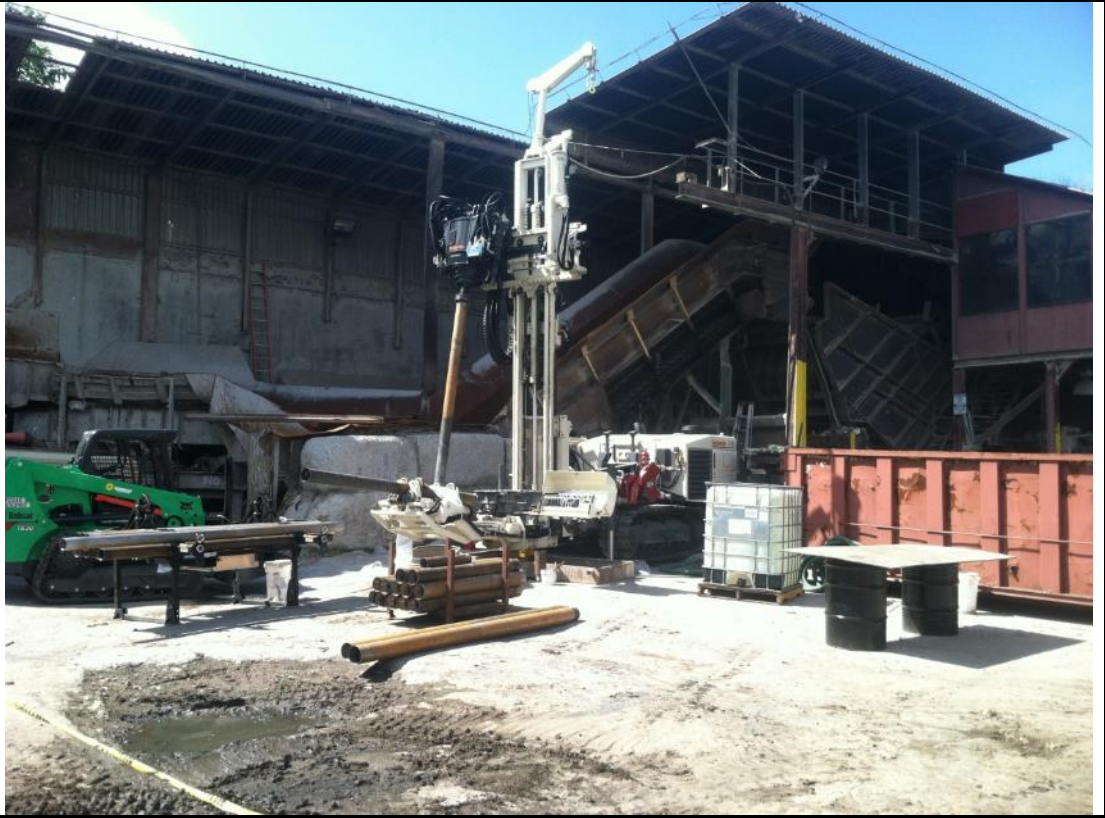
Drill rig setup on the southern portion of 222 Maspeth (SB-108 location).

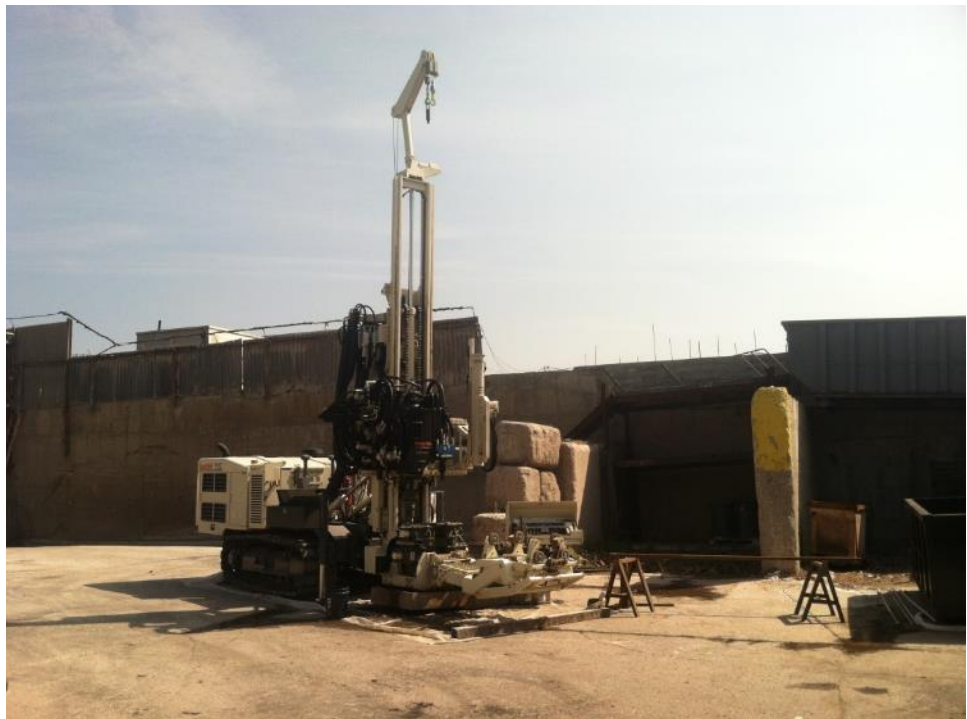
**Photo No.**  
10

Drill rig setup on the eastern portion of 222 Maspeth (SB-101 location).

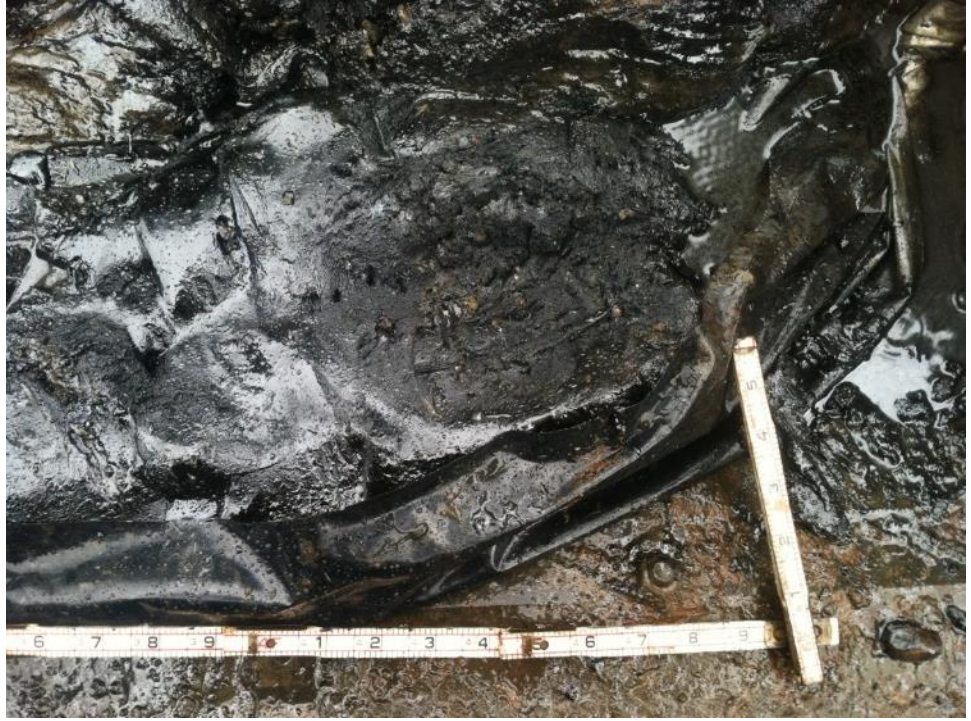
Example of NAPL saturation at RW-25/SB-102 location (24-26 feet below grade, above bottom of gas holder).

In response to NAPL impacts noted within the former No. 1 relief holder foundation, two borings (SB-101 and SB-102) were converted to 6-inch NAPL recovery wells (RW-24 and RW-25, respectively). These wells will be incorporated into the existing NAPL recovery program, including periodic gauging and removal of accumulated NAPL within the recovery wells. Other boring locations containing subsurface residuals are covered by the developed property or near existing NAPL recovery wells and do not present an open exposure pathway as the residuals are isolated from human contact.

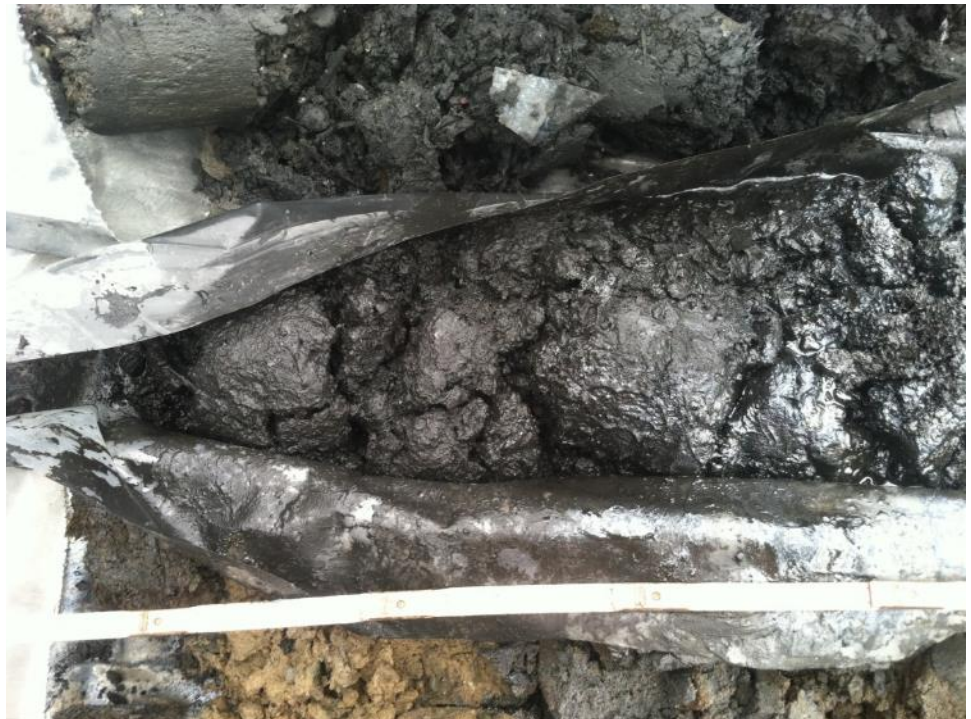
**Photo No.**  
12

Example of NAPL coating and sheen at SB-105 location (15-17 feet below grade).

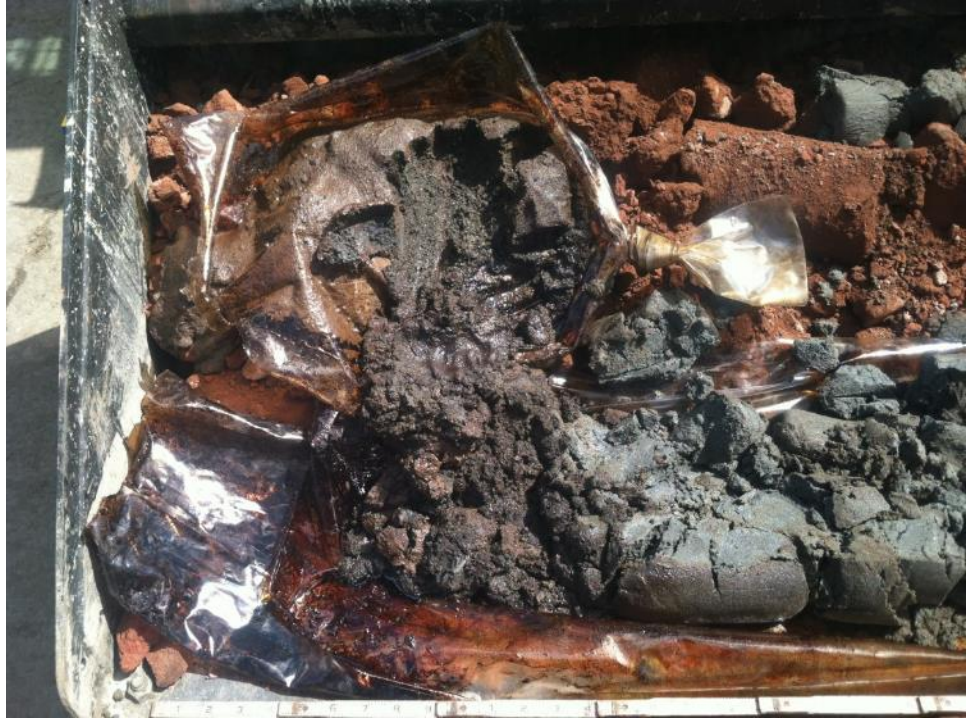
Example of NAPL saturation at SB-104 location (30-32 feet below grade).

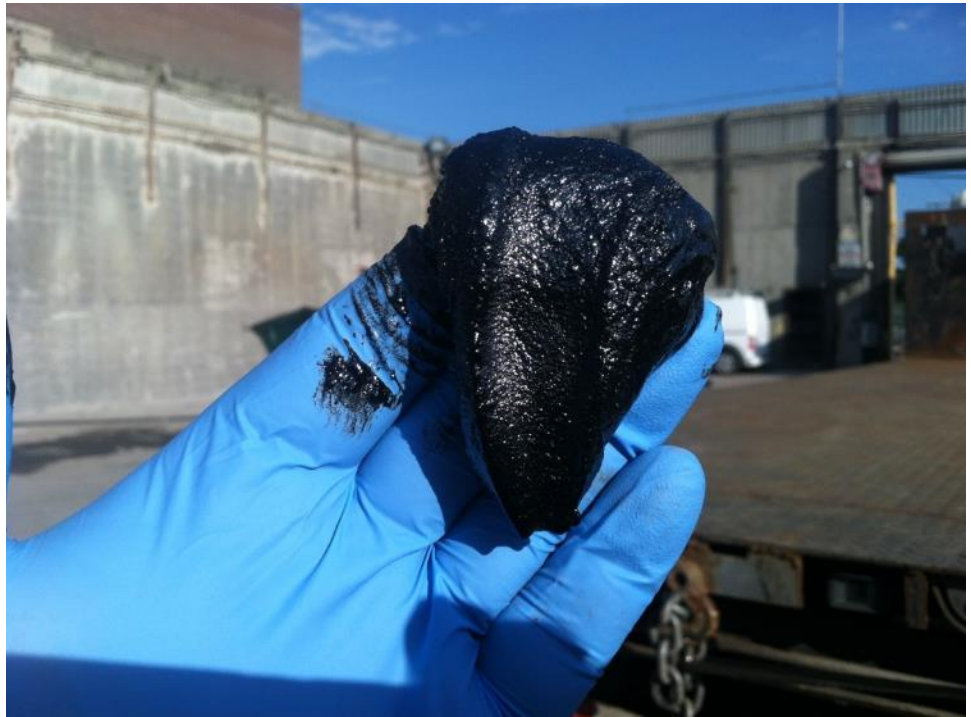
**Photo No.**  
14

Example of black viscous NAPL present at RW-25/SB-102 location (24-26 feet below grade, above bottom of former gas holder).
