# Fourth Annual Report Interim Remedial Measure for NAPL Recovery

August 2017 Through July 2018 Former Equity Works MGP Site, Brooklyn, New York

NYSDEC Site No.: 224050

**National Grid**

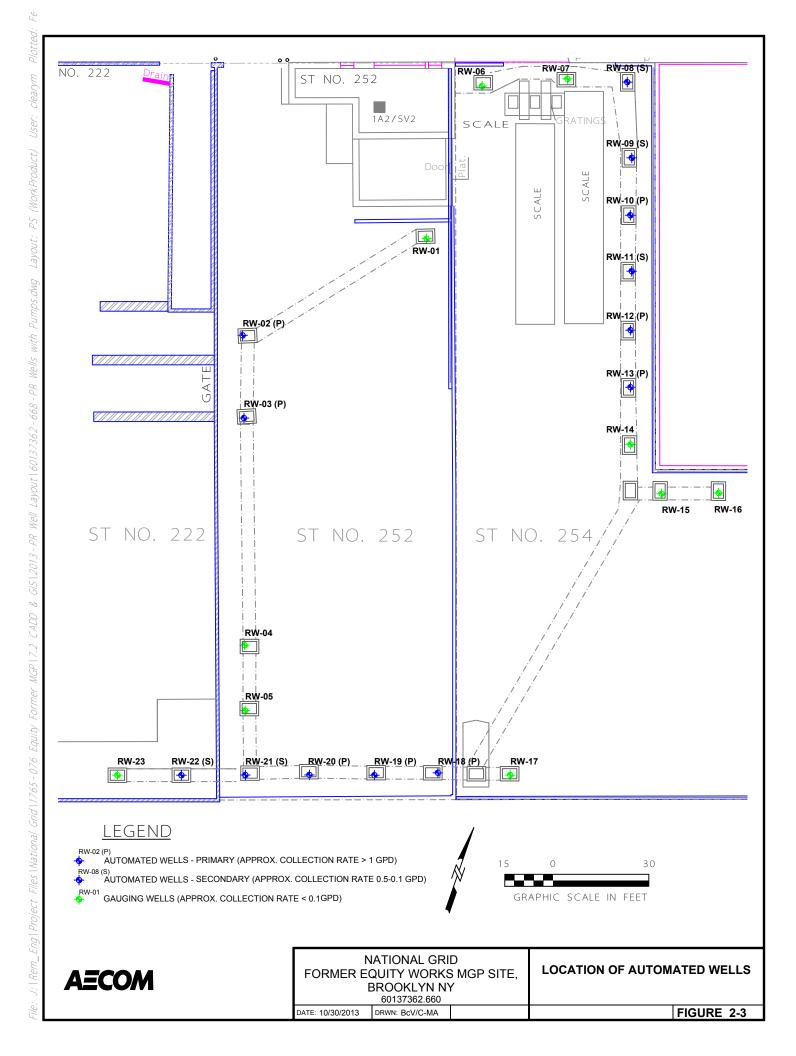
Figure 2-2

COMPLETED WELL LOCATION

Recovery wells were designed to accommodate the uncertainty of long-term NAPL recovery rates. All well risers were constructed of 6-inch diameter schedule 40 polyvinyl chloride (PVC). Recovery well screens were constructed of 6-inch diameter 0.020-inch slot wire wrap stainless steel. Five (5) and ten (10) foot lengths of screen were used, as required, to address soil intervals where NAPL (i.e., saturated thickness greater than 1-inch) have been observed. Centralizers were installed at the top and bottom of each screen. The screen size was selected based on the grain-size information obtained during the Pre-Design Investigation (PDI). Each well was equipped with a 5-foot long, 6-inch diameter, stainless steel sump to collect NAPL. The annular space above the filter pack was filled with a bentonite seal (minimum of 3 to 4 feet thick). Note that additional bentonite seals were used at locations where multiple screen intervals were installed. The annular space above the bentonite seal was filled with a grout mixture from the bentonite seal to approximately one to two feet below the top of casing (TOC). Each recovery well was completed in a 4-foot by 4-foot traffic rated well vault. Illustrations of an in-place recovery well and completed well location are provided in Figure 2-2.

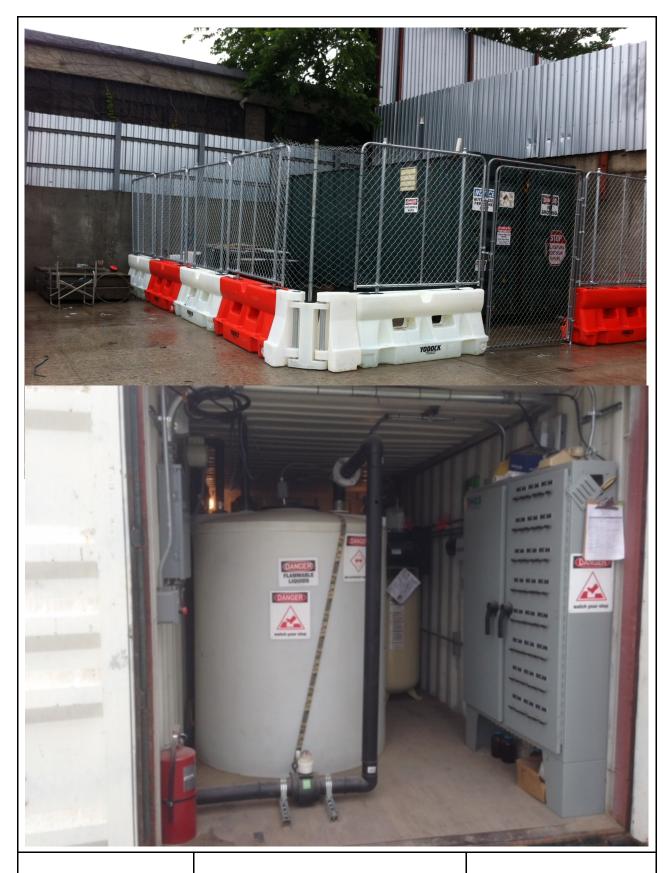
Figure 2-4

**CONTROL TRAILER**

Collected NAPL is accumulated in a 500 gallon capacity double-walled polyethylene tank located above ground in the system's control trailer on the 254 parcel (Figure 2-4). The accumulation tank is equipped with a high liquid level detector to prevent over-filling, as well as secondary containment. The system is equipped with additional alarms and communication equipment to ensure its safe operation.

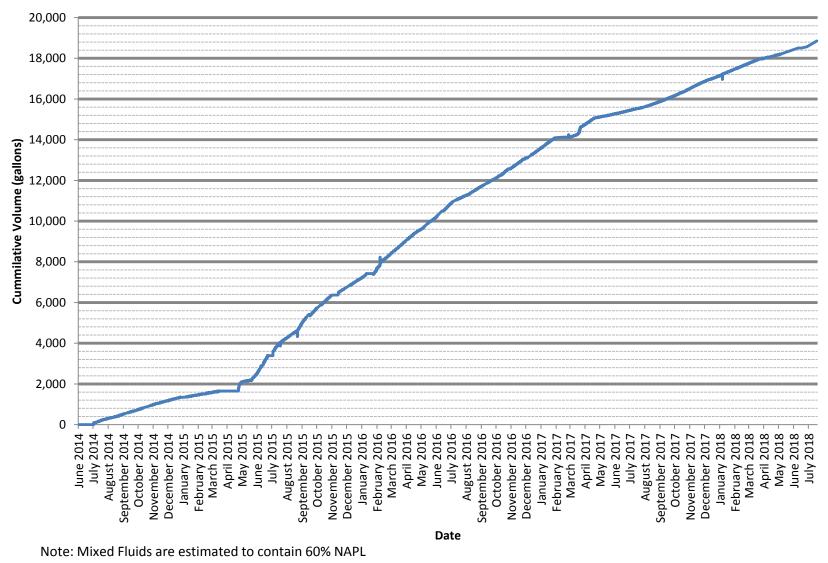
Figure 3-1
Cumulative Volume of Mixed Fluids Collected
IRM for NAPL Recovery
Former Equity Works MGP Site

Approximately 3,311 gallons of mixed fluids were collected from the system during the fourth year of operation (August 1, 2017 through July 31, 2018). An illustration of the cumulative volume of mixed fluids collected over time is provided in Figure 3-1. From startup through July 2018, approximately 18,855 gallons of mixed fluids have been removed by the system based on readings from the level sensor in the recovery tank. Note that the estimates of total recovered volume presented in Table 3-1 (based on in truck volumes listed on the manifests) can vary slightly from the "tank" level sensor estimate due to the variability over time between the level sensor readings and the "in truck" volumes recorded by the waste hauling company. In the past, observation of the relative proportions of organic/water have been highly variable; however, the use of the standardized protocol presented in the Year 2 Report has provided more consistent results. During Year 4 operations, the observed NAPL to water ratio of collected mixed fluids was approximately 50 to 60% NAPL. A conservative estimate of the organic/water ratios since system startup indicates that the collected material likely contained over 10,300 gallons of NAPL.

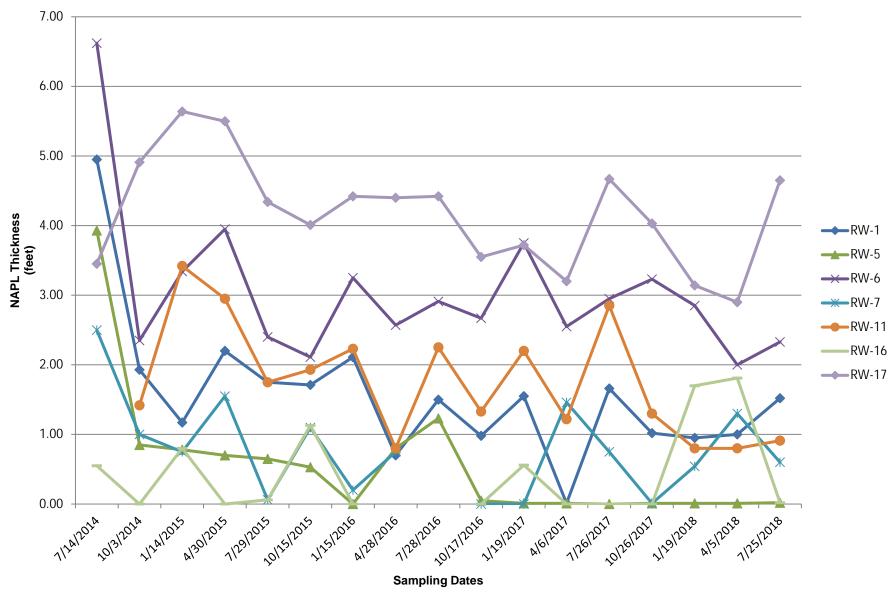
Figure 3-2
NAPL Thickness Versus Time - Gauging Wells
Former Equity Works MGP Site, Brooklyn, New York

Figure 3-2 presents a graphical illustration of the trend in DNAPL thickness in the "gauging" recovery wells during the first four years of operation. As illustrated, thicknesses have generally decreased over time with typical variation. This suggests that the collection system is having a potentially significant effect on reducing the quantity of recoverable DNAPL in the areas where the gauging wells are located.

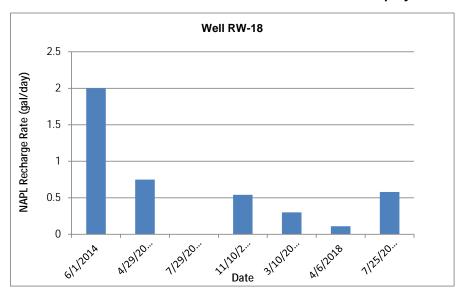
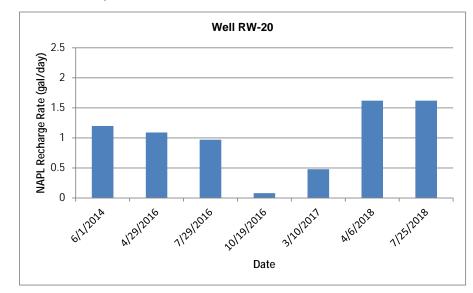
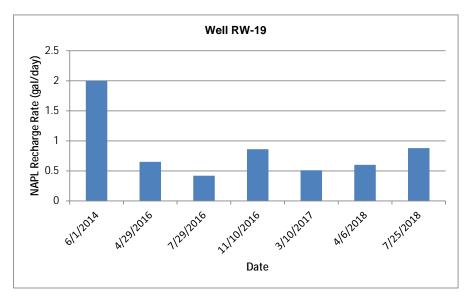
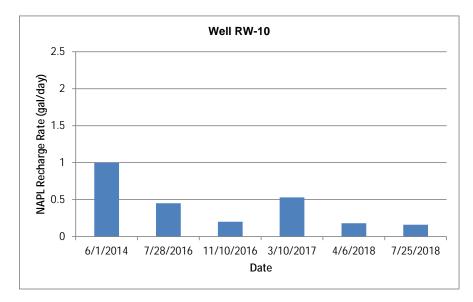
Figure 4-1
NAPL Recharge Rates Versus Time - Automated Wells
Former Equity Works MGP Site, Brooklyn, New York

Starting in June 2014, and continued during various quarterly gauging events, a pilot program was initiated to evaluate the recharge rates for select wells. During the evaluation, NAPL was removed from the well and NAPL thicknesses were monitored periodically over the next 24 hours, with results reported in gallons/day. The results for three wells located along the southern edge of the 252 Maspeth Avenue parcel (RW-18, -19 and -20) and one well along the eastern edge of the 254 Maspeth Avenue parcel (RW-10) are summarized in Figure 4-1. As illustrated, NAPL recharge rates for prior years indicate a decreasing trend, with expected variability.
