Seventh Annual Report for NAPL Recovery

August 2020 Through July 2021
K- Equity Works (Former MGP Site), Brooklyn, New York
NYSDEC Site No.: 224050
Order on Consent Index #: A2-0552-0606
EPA ID number for the Site: NYR 000 225 615

National Grid

October 28, 2021

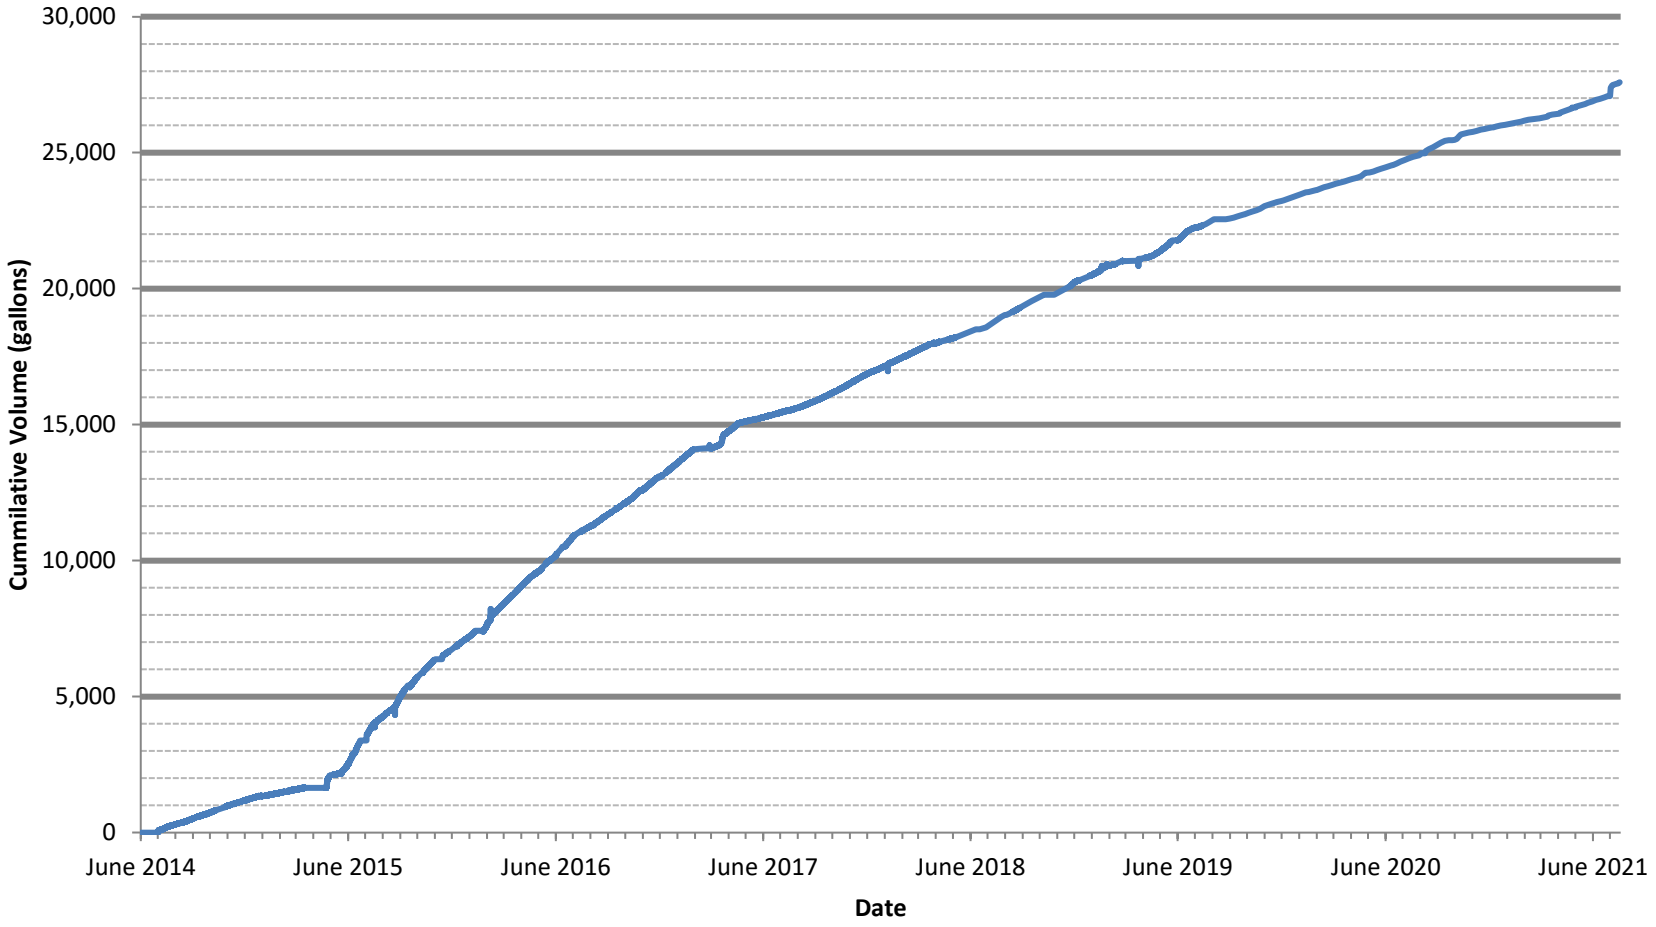
Figure 3-1
Cumulative Volume of Mixed Fluids Collected
IRM for NAPL Recovery
Former Equity Works MGP Site

Approximately 2,745 gallons of mixed fluids were collected from the system during the seventh year of operation (August 1, 2020 through July 31, 2021). An illustration of the cumulative volume of mixed fluids collected over time is provided in Figure 3-1. From startup through July 2021, approximately 27,592 gallons of mixed fluids have been removed by the system based on readings from the level sensor in the recovery tank. Note that the estimates of total recovered volume presented in Table 3-1 (based on in-truck volumes listed on the manifests) can vary slightly from the "tank" level sensor estimate due to the variability over time between the level sensor readings and the "in-truck" volumes recorded by the waste hauling company.

In the past, observation of the relative proportions of NAPL/water have been highly variable; however, the use of the standardized protocol presented in the Year 2 Report including lowering the probe to the bottom of the recovery tank and letting it equilibrate for approximately five minutes prior to recording the NAPL and water thicknesses has provided more consistent results. During Year 7 operations, the observed NAPL to water ratio of collected mixed fluids was approximately 60% to 70% NAPL. A conservative estimate of the NAPL/water ratios since system startup indicates that the collected material likely contained over 16,500 gallons of NAPL.

Note: Mixed Fluids are estimated to contain 60% NAPL

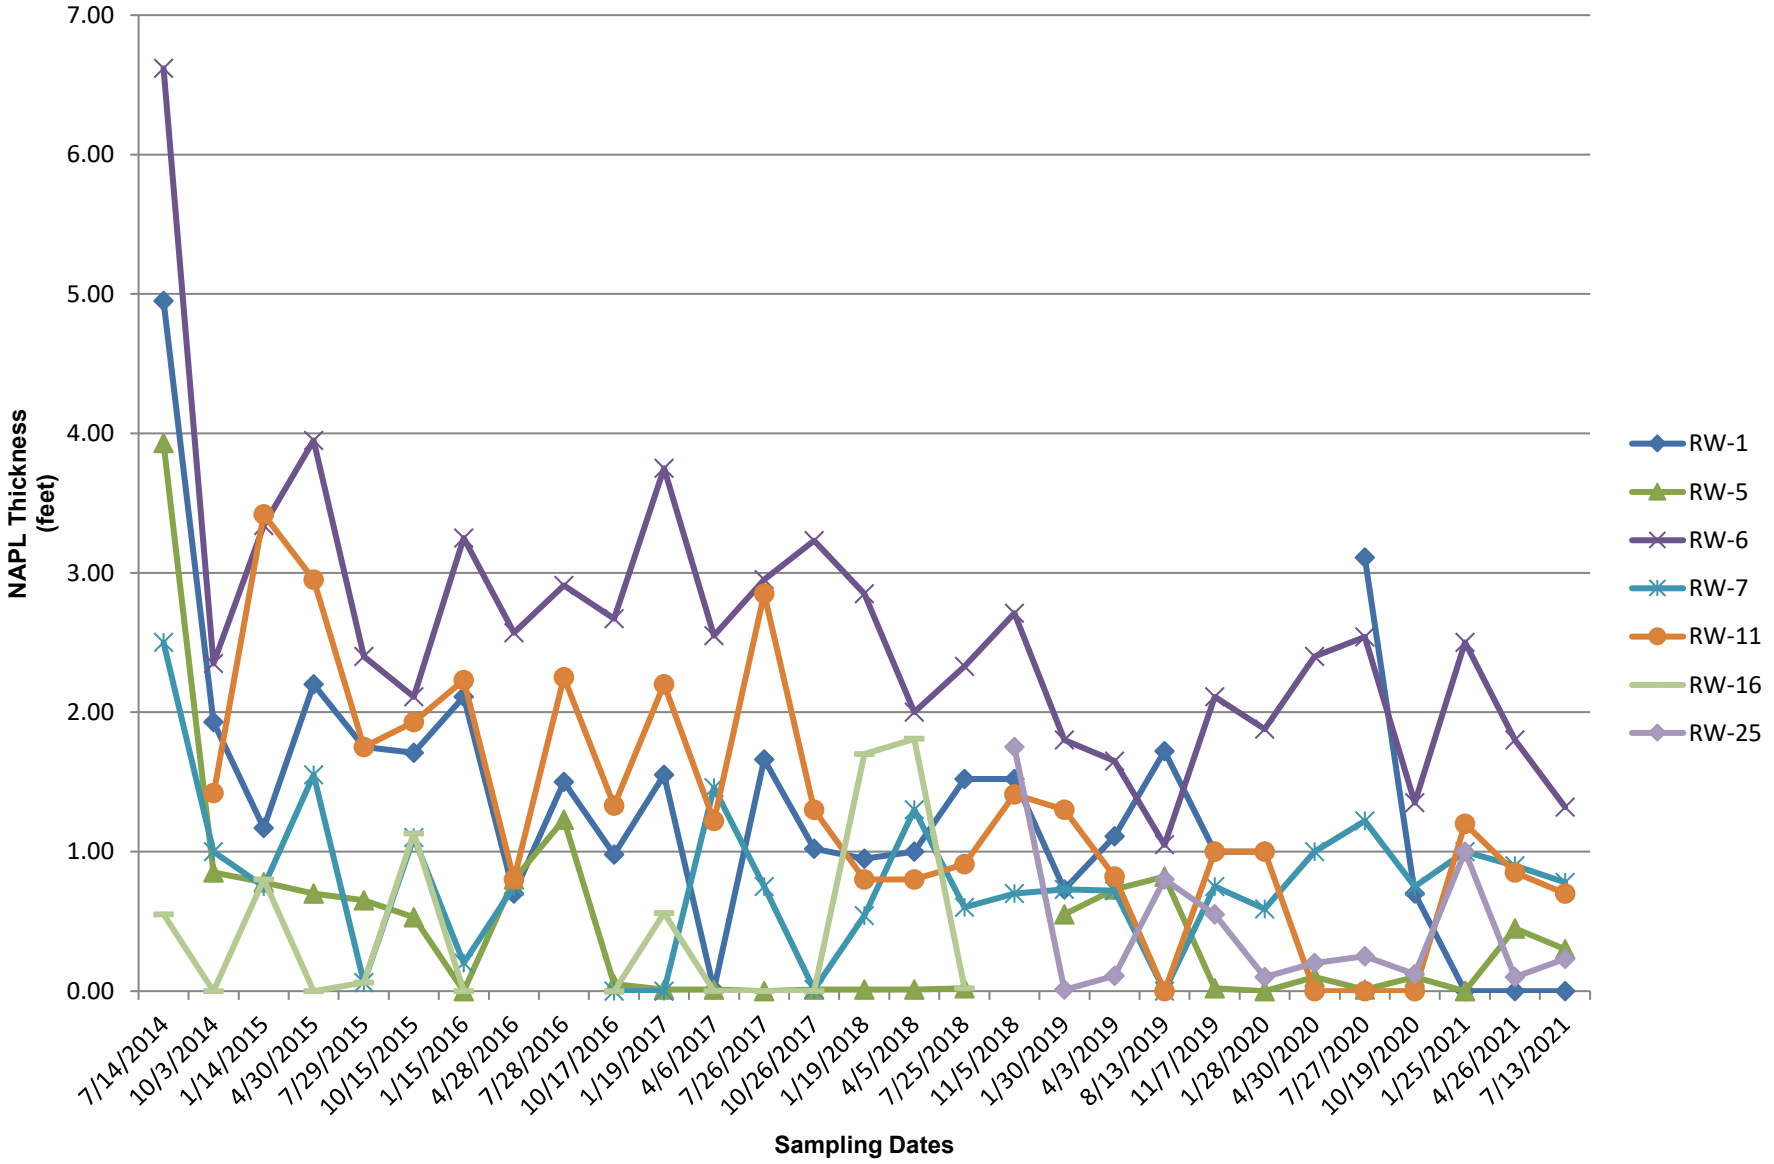
Figure 3-2
NAPL Thickness Versus Time - Gauging Wells
Former Equity Works MGP Site, Brooklyn, New York

Figure 3-2 presents a graphical illustration of the trend in DNAPL thickness in the "gauging" recovery wells during the first seven years of operation. As illustrated, thicknesses have generally decreased over time with typical variation. This suggests that the collection system is having a potentially significant effect on reducing the quantity of recoverable DNAPL in the areas where the gauging wells are located.

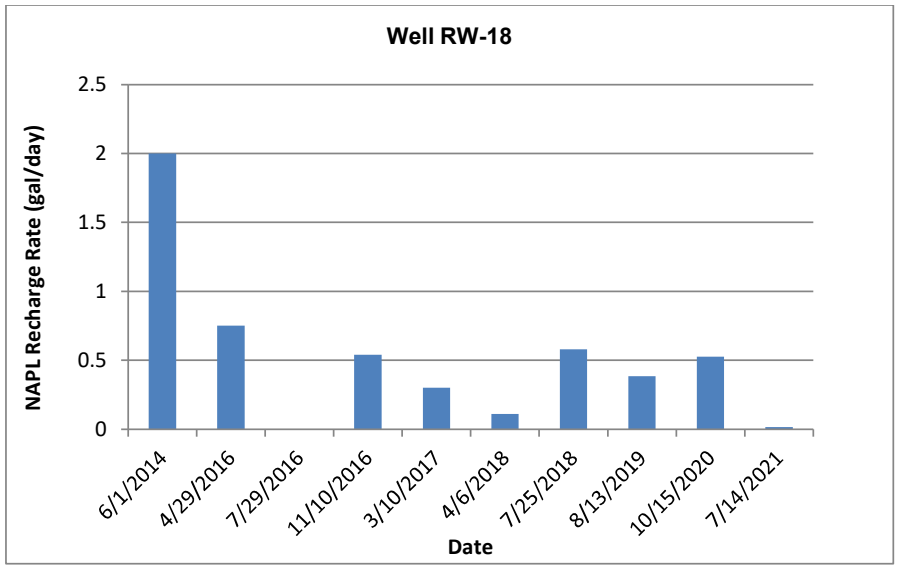
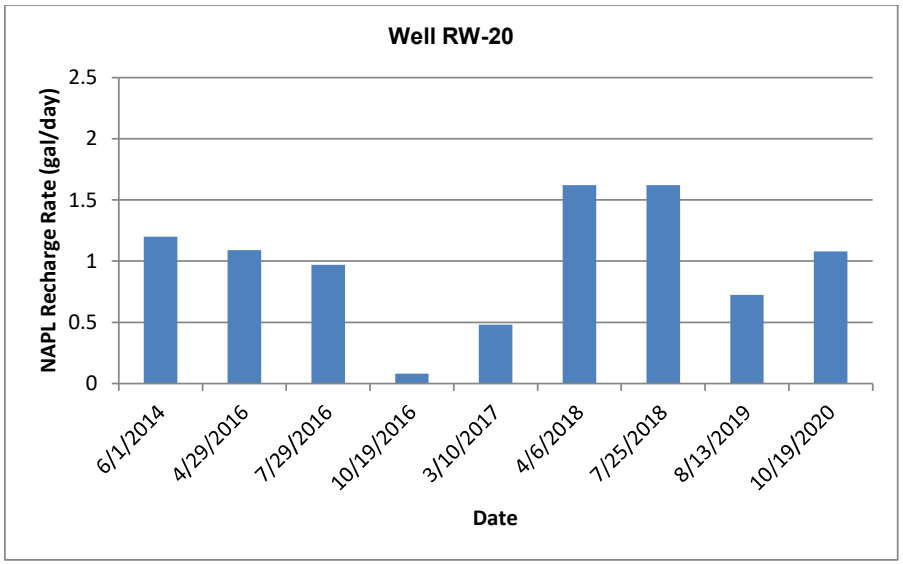
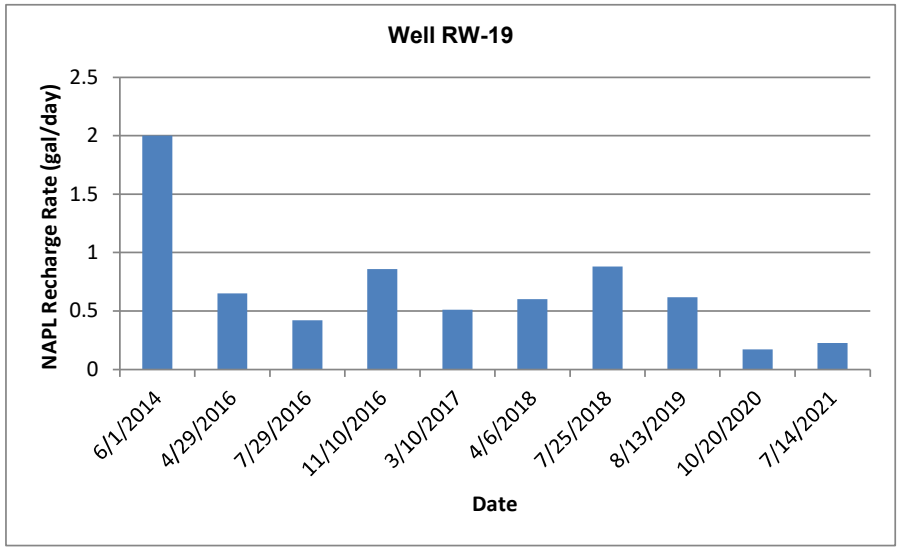
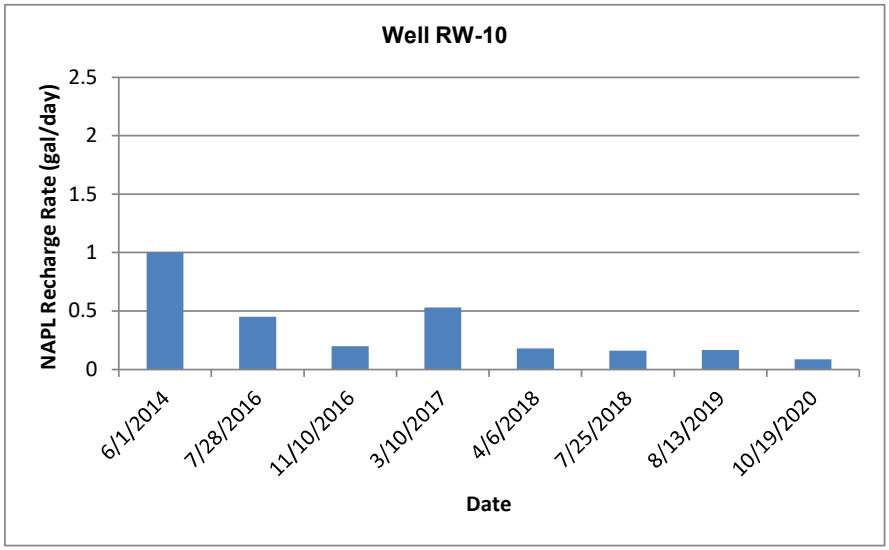
Figure 4-1
NAPL Recharge Rates Versus Time - Automated Wells
Former Equity Works MGP Site, Brooklyn, New York

Starting in June 2014, and continuing forward during various quarterly gauging events, a pilot program was initiated to evaluate the recharge rates for selected wells. During the evaluation, NAPL was removed from the selected wells, and NAPL thickness was monitored periodically over the next 24 hours or longer, with results reported in gallons/day. The results for four wells (RW-10, RW-18, RW-19, and RW-20) are summarized in Figure 4-1. In Year 7, recharge rates were evaluated for two (RW-18 and RW-19) of the wells, both of which are located along the southern edge of the 252 Maspeth Avenue parcel. Well RW-10, along the eastern edge of the 254 Maspeth Avenue parcel, and well RW-20 along the southern edge of the 252 Maspeth Avenue parcel, were unavailable for recharge rate testing in Year 7 during the July 2021 monitoring event due to a pump replacement issue at RW-10 and ongoing active pumping at RW-20. As illustrated on Figure 4-1, NAPL recharge rates indicate a decreasing trend, with some expected variability. Data collected during Year 7 operations indicated a continued decrease in NAPL recharge rates in RW-18, and RW-19 compared to baseline (2014) levels. This is expected as the NAPL is continually removed from the subsurface. The evaluation will be continued at these wells and possibly additional wells during Year 8 operations.

During Year 3 operations, National Grid also conducted a recharge evaluation to evaluate the possibility that the decreasing recharge rates could be associated with “fouling” of the well screens. The results from the evaluation were presented in the Year 3 Annual Report (AECOM, 2017) and demonstrated that significant NAPL recharge was noted in all wells, confirming that recovery well screen fouling is not an issue or the cause of the gradually decreasing recharge rates.

The NAPL recovery system was switched from daily to weekly pumping on July 27, 2020 in an attempt to improve NAPL to water collection ratios. Results from recorded NAPL to water ratios in the recovery tank during Year 7 indicate an approximate 10% reduction in water content of the recovered NAPL following this change to weekly pumping. The results of the above actions will be reviewed as part of the next annual report to determine if there is a trend in the rate of NAPL collection and if any modifications to the operation of the system are required.
